## ASSESSMENT OF HIGH VELOCITY IMPACTS ON EXPOSED SPACE SHUTTLE SURFACES

Eric L. Christiansen,\* Ronald P. Bernhard,\*\* James L. Hyde,\*\*  
Justin H. Kerr,\* Karen S. Edelstein,\*  
Javier Ortega,\*\* and Jeanne Lee Crews\*

\*NASA Lyndon B. Johnson Space Center  
\*\*Lockheed Engineering and Sciences Company  
Houston, TX 77058

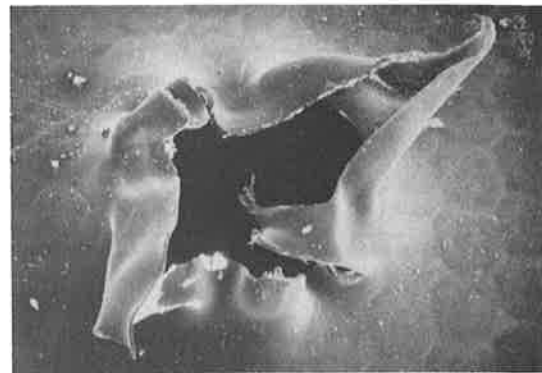
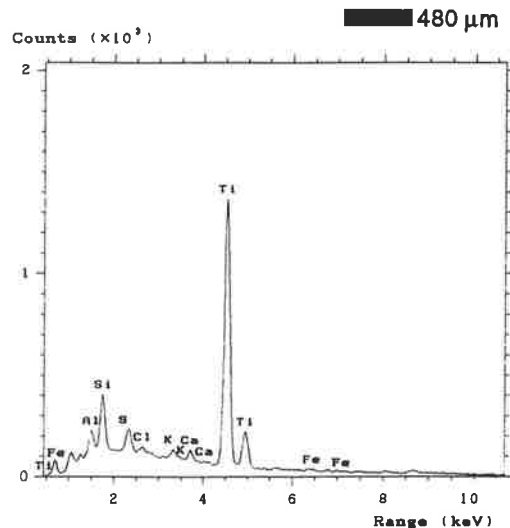
Figure 4. SEM Image and EDX Spectrum of Largest STS-50 Radiator Tape Impact

Table 1 also provides SEM/EDX results. In 6 of the 16 radiator tape samples (38%), the SEM/EDX spectrum indicated that orbital debris was the likely source of the impact damage: 4 with elemental constituents indicating impact by spacecraft paint, 1 by stainless steel, and 1 by a titanium-rich particle (possibly titanium metal). The SEM image and X-ray spectrum for the largest impact is shown in Figure 4. This was classified as an orbital debris impact from spacecraft paint because of the large amounts of titanium (paint pigment), silicon, chlorine, potassium, and calcium (inorganic binders) found in and around the impact site. Two of the 4 "paint" impacts had high levels of zinc as well as titanium. In 5 of the 16 samples (31%), material associated with the impact had detectable amounts of elements typically found in cosmic dust meteoroid particles (Si, Mg, Al, Ca, Na, Fe, Cl). In the remaining 5 samples (31%), no detectable remnant projectile material was found. This is due to vaporization of projectile during impact, and/or ejecta of projectile material, resulting in insufficient mass within the impact to yield x-ray counts (Ref. 7). Some of the unknowns had high aluminum content but it was not certain whether the aluminum detected resulted from the impacting projectile or damage to the aluminum facesheet of the radiator panel.

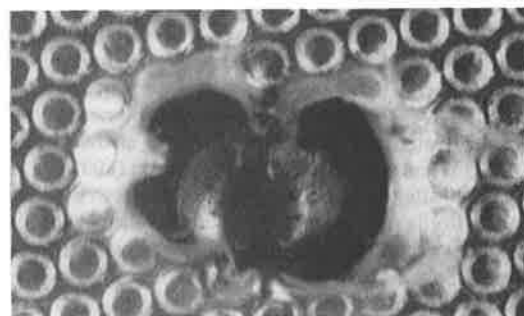
Figure 5. Results of HVI Test No. 2331 on Radiator Specimen (0.4 mm Aluminum projectile, 70° impact, 7.59 km/sec)

A series of hypervelocity impact (HVI) tests were performed at the JSC HIT-F on representative samples of the radiator (Ref. 8). Samples consisted of the silver-Teflon thermal coating used on the Orbiters bonded to aluminum honeycomb. Figure 5 shows the results of an impact by a 0.4 mm diameter aluminum sphere impacting at 7.59 km/sec and 70° to the normal of the radiator panel (Shot 2331). The silver-Teflon tape has a hole measuring 3.1 mm x 2.2 mm at the surface and a through-crack has formed at the bottom of the crater in the aluminum face-sheet (threshold perforation). This resembles impact damage found on the STS-50 radiators.

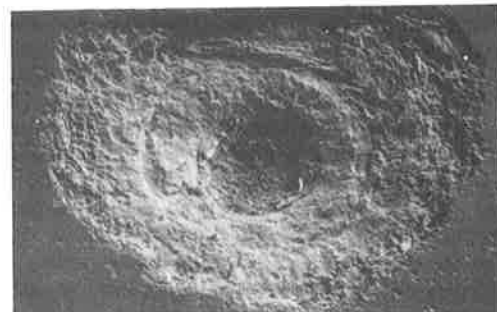
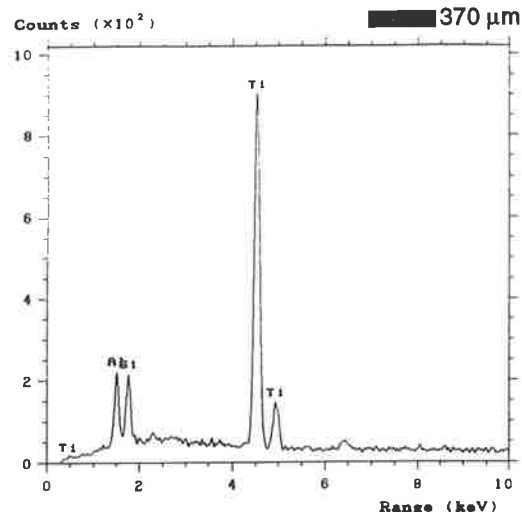
Figure 7. SEM Image and EDX Spectrum of Largest STS-50 Window Impact

Analysis of particles with melt-like morphology found in the largest STS-50 window impact revealed that the impactor was a particle of man-made origin. As shown in the spectrum in Figure 7, the impactor was a titanium rich particle. A small amount of aluminum was also found. Materials of meteoritic origin were found in another impact, while the source of the third impact pit is unknown. Traces of aluminum were found in the third impact site, but because of large amounts of contamination also present, it was not certain that the aluminum originated from the impacting particle.
