COLUMBUS APM SHELL REPAIR TEST RESULTS

Carlo Viberti ⁽¹⁾, Wubbo Ockels ⁽²⁾, Rolf Jonsson ⁽³⁾

This paper presents the results of a first series of tests which were carried out at the end of 1992 at ESA/ESTEC by the Columbus crew activities office.

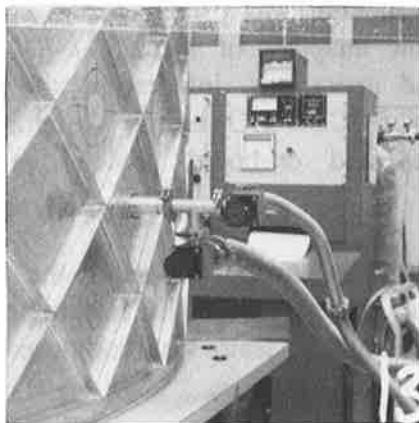
Fig. 1: test configuration

The connecting hose was outfitted with a bellow-sealed valve to control the airflow into the vacuum chamber and a connection to a helium leakage detector (Ultratest F/F AG, see fig. 1).

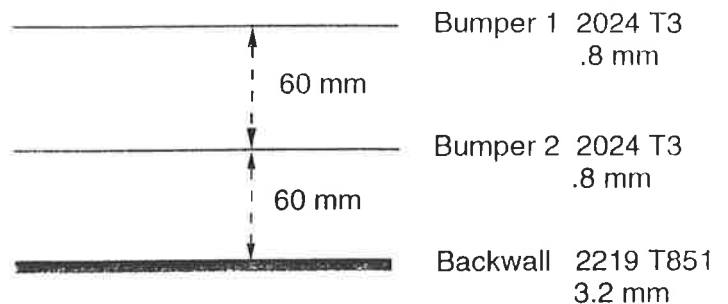
Fig. 2 The micro meteoroid and debris protection system

For the first test run, a portion of the APM shell provided by Alenia Spazio (Torino, I) was used as target hardware: two small apertures (holes) had been drilled into respective panels to simulate impact holes passing through the shell protection system (MDPS) down to the shell itself or "backwall" (fig. 2).

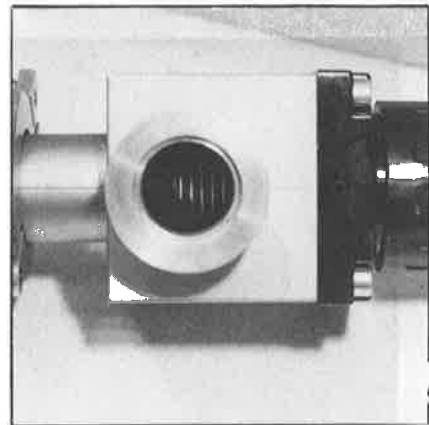
Fig. 4: clay bits, torn off by depressure, found inside the valve

- some tiny bits of clay were found extruded in the hoses and valves (fig. 4)

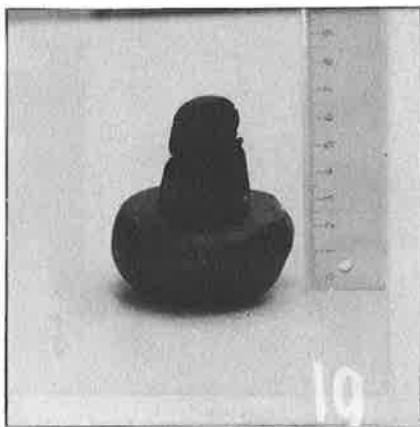
- a relevant amount of material choked the hole beyond the shell backwall, by intruding into and beyond the 25 mm diameter aperture, down into the interface device for 4 cm: as a consequence, after disassembly the sample of sealing clay was found assuming a "fungus"-type shape (fig. 5)

- partial cracking on the external surfaces of the mentioned intrusion appendix was identified (fig. 5)

Fig. 5: sealing clay after removal

Such a clay needs to be stiffened by some additional compound or by fabric: this is the subject for further tests, with the aim of bettering the clay resistance to those bending and shear forces resulting from the strong pressure differential the clay 'patch' is subjected to.

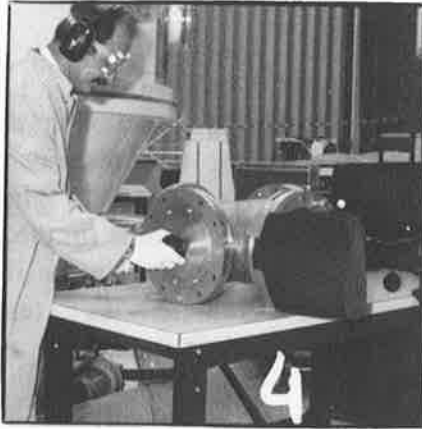
Fig. 6: W. Ockels testing repair methods with the cross-flanged test setup

The shell sample plate was mounted on a flange of a cross interface piece, provided with four nozzles (fig. 6) where two nozzles were closed by transparent panels to allow for two videocameras to film the sealing phenomena from two different viewpoints, both downstream with respect to the area from where the test subject would perform the repair test.

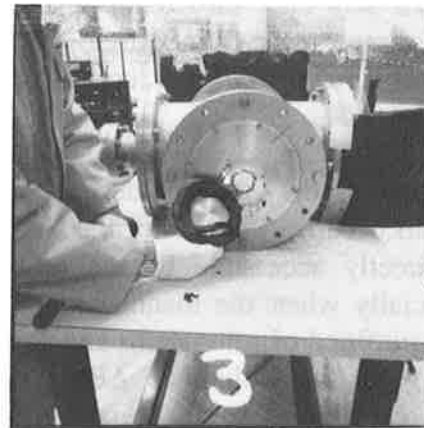
After the first test run, an analysis of the clay ring sealing the aluminum plate against the backwall showed that the high pressure force, exercised via the sharp edge of the plate border at the coupling between the plate and the shell, almost fractured the clay layer forming the sealing ring (fig. 7).

Fig. 7: the clay ring cracking at the plate-shell coupling
