A HISTORY OF METEOROID AND ORBITAL DEBRIS IMPACTS ON THE SPACE SHUTTLE

J.L. Hyde⁽¹⁾, E.L. Christiansen⁽²⁾, R.P. Bernhard⁽³⁾, J.H. Kerr⁽⁴⁾, D.M. Lear⁽³⁾

ABSTRACT

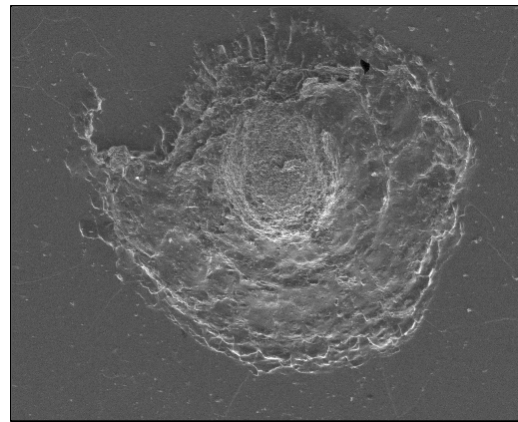
The largest impact to an Orbiter window occurred on STS-92, which was International Space Station (ISS) Flight 3A. A crater 10mm diameter by 1.9mm deep was found on the port-middle (#2) debris pane (Fig.2). SEM/EDX analysis indicated the cause of the damage was a piece of paint (orbital debris). The window was replaced. Based on average impact conditions for this mission (impact velocity of 9.3km/s and impact angle of 45°), the crater geometry can be best explained by a 0.76mm diameter by 0.3mm thick paint chip that impacts the window in an edge-on orientation.

Fig. 2. STS-92 Left Hand (LH) #2 window crater caused by spacecraft paint debris impact (crater is 10mm diameter x 1.9mm deep)

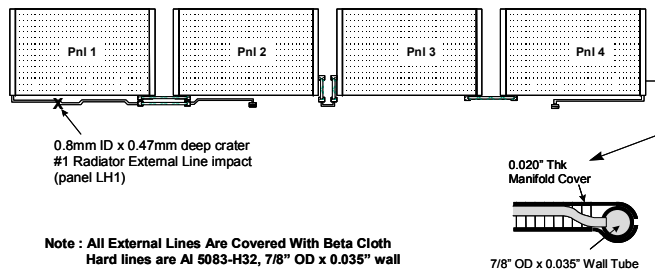
Probably the severest impact to the Shuttle fleet as it represents a “near miss” of a major problem is the impact found on a radiator line after STS-86 [3]. Post-flight inspection of OV-104 (*Atlantis*) radiator panels after mission STS-86 found a significant hypervelocity impact in the external manifold hard line that extends along the two forward panels (Fig. 4).

Fig. 4. External manifold impact location post STS-86

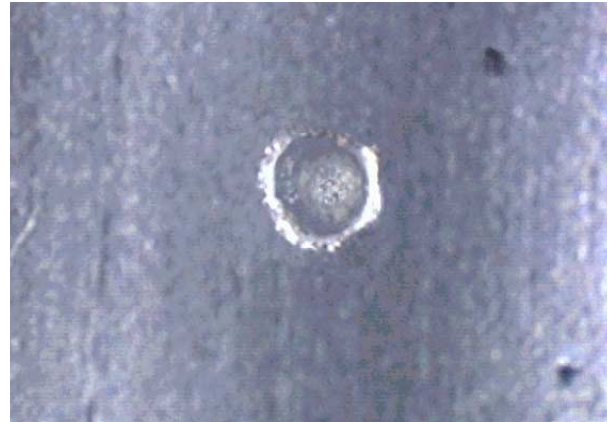
The impact penetrated through a beta cloth cover, crossed a 6.4mm (0.25 inch) gap, and left a 0.8 mm diameter by 0.47 mm deep crater in the manifold hard line (Fig. 5). The aluminum external hard lines are 0.9mm (0.035 inch) thick in the impacted region. From hypervelocity impact data, the crater depth to wall thickness ratio of 0.52 indicated spall effects were likely on the inside of the line at the point of impact [13]. A borescope inspection of the line interior was conducted to assess internal damage and a small area of detached spall was found on the inside of the tube under the impact site (Fig. 6). This indicates the impact very nearly put a hole in the external manifold that would have caused a leak of freon coolant, potentially shortening the mission. Mission rules dictate that a leak in one of the Orbiter’s two radiator systems will result in a next primary landing site (PLS) abort. The Orbiter Project Office determined that an upgrade to the meteoroid/debris protection of the radiator external lines was needed, and additional two ply beta-cloth sleeves were installed on all external radiator lines.

Samples obtained for SEM/EDX analysis included the perforated beta cloth thermal cover and tape pull samples from the external line. Analysis found iron (Fe), chromium (Cr), and nickel (Ni) on the beta cloth (teflon-glass background) and in the external line samples, indicating the damage was caused by a stainless steel orbital debris particle (approximately 0.4mm diameter as indicated in Table 1).

Fig. 5. Crater (0.8mm dia. by 0.47mm deep) in the 0.9mm thick aluminum line. SEM/EDXA revealed the impactor was a steel debris particle

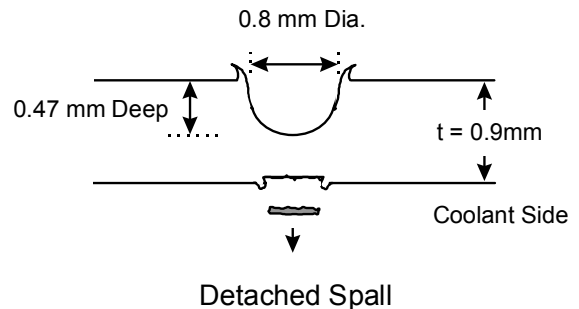
Fig. 6. Crater profile in external line. Detached spall found on inside of line in borescope inspection. Small metal pieces were found in a coolant pump strainer post-flight.
