TESTS TO ASSESS THE VULNERABILITY OF ADEOS-2 AND ETS-8 TO DEBRIS AND MICROMETEOROID IMPACTS

Michael J. Neish, Masato Takahashi, Hironori Maejima, Hiroaki Kusawake, Shirou Kawakita, Tateo Goka

Japan Aerospace Exploration Agency, 2-1-1 Sengen, Tsukuba City, Ibaraki Pref. 305-8505, Japan.
E-mail: mike@jaxa.jp, takahashi.masato@jaxa.jp, maejima.hironori@jaxa.jp, kusawake.hiroaki@jaxa.jp,
kawakita.shirou@jaxa.jp

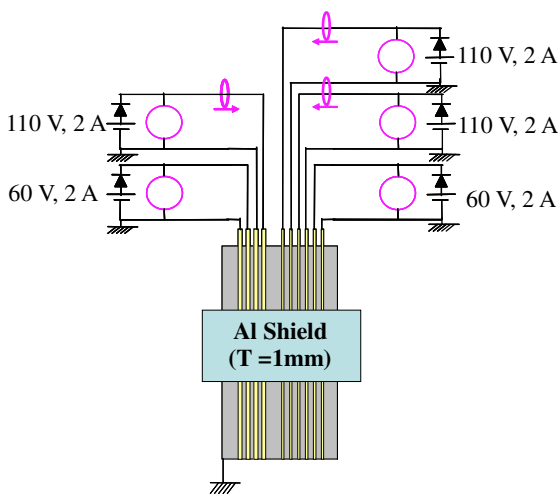
Figure 3. Configuration of the harness mock-up.

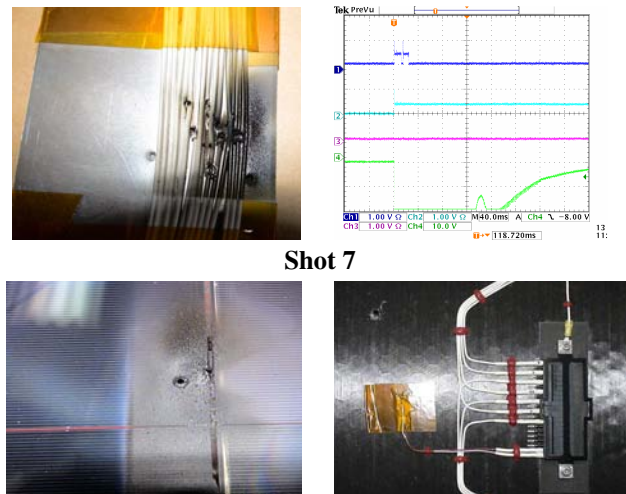
Fig. 4 shows images of the results of the most interesting of the tests, shots 7 and 8. Wires hit by the projectiles in shot 7 were completely ruptured. In addition a sustained arc was caused in two of the circuits. This projectile size was therefore deemed to be hazardous to individual wires, and possibly to the harness as well. Shot 8 resulted in complete perforation of the panel. However, no significant disruption to the electric current was observed. The exit hole diameter measured about 2-3 mm across, i.e. 4-6 times larger than the projectile diameter, large enough to cover two wires should the perforation occur directly below them. Complete rupture of two adjacent wires is therefore a possibility.

Figure 4. Shot 7, 500- μm alumina beads fired at 3.3-3.4 km sec^{-1} : (left) the target, (right) the oscilloscope trace taken over a period of about 100 ms at the time of impact. Shot 8, 450-600- μm alumina beads at 3.27-3.86 km sec^{-1} : (left) the front face, (right) the rear face showing the exit hole. Images are not to scale.

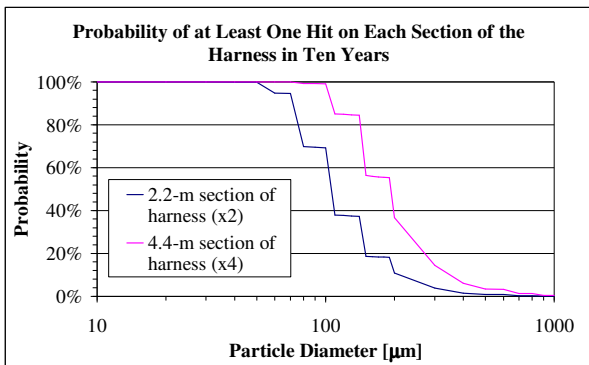
Having identified the modes of failure to be considered, MASTER-2001 is used to determine the base particle fluxes that can be used to calculate failure probabilities, wire by wire. Fig. 5 shows the probability of at least one hit on either section of the wire harness in ten years. According to this chart, the probability of a 500- μm particle striking the 4.4-m section of the harness is about 3.4%, and 0.85% on the 2.2-m section. Fig. 6 shows the probability that two adjacent wires are hit by a single impact at least once during the ten-year mission of ETS-8, scenario b). This is meaningful only if a hit on one wire causes damage extending into the adjacent wire. The area of impact is taken to be the shaded region in the inset of Fig. 6, the right-hand half of the left wire, and the left-hand half of the right wire, assuming both are in

Figure 5. Probability of at least one hit on each section of the wire harness in ten years.

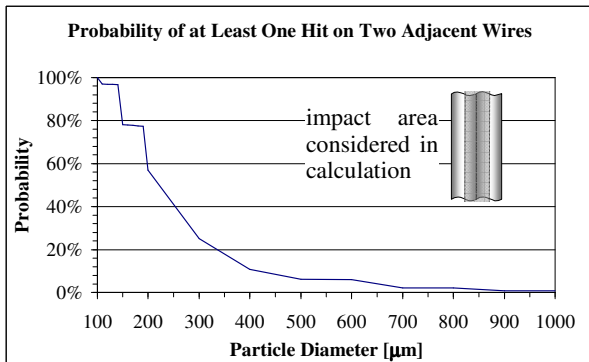
Estimation of the critical size required for a double rupture is difficult using the results of the tests so far conducted, as this will depend on impact angle and velocity. Until more test results are available, $d \geq 500 \mu\text{m}$ will be taken as a possible critical diameter range.

Figure 6. The probability that a single particle strikes two adjacent power lines (hot-hot or return-return) at least once during the ten-year mission of ETS-8.

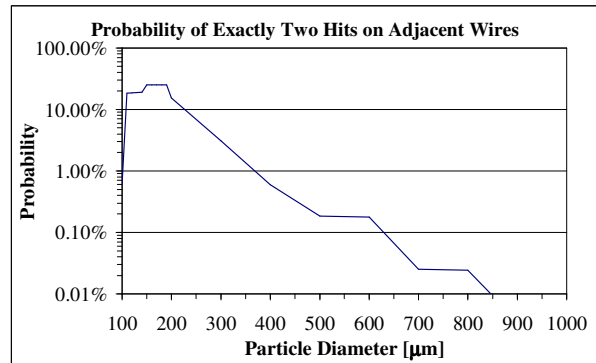
Fig. 7, shows the probability that two adjacent wires are hit by a single impact *exactly twice* during in ten years. The impact surface area also corresponds to that shown in Fig. 6. This corresponds to a loss of 4/88 of the total power (two solar array sections lost), and could therefore have an impact on mission operations. The probability becomes greater than 1% between 200 and 300 μm, at which size complete rupture of two wires, or even a single wire, may not occur – so this scenario does not appear significant. Fig. 8 illustrates scenario c) in Table 1: a particle hits one wire, then another its back-up. The probability is also for ten years, and becomes significant (> 1%) below about 200 μm. From Shot 3 of the impact tests it appears unlikely that this particle diameter would be a threat to a single wire. 4-500-μm particles could be sufficiently large, but from Fig. 8 it can be seen that the probability is low enough that this scenario can be neglected.

Figure 7. The probability that exactly two adjacent wires are hit by one impact, twice.

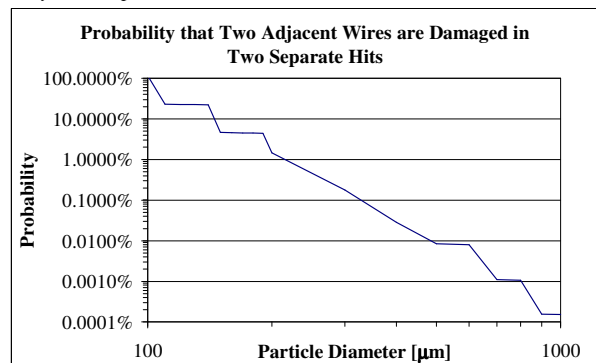
Figure 8. The probability that two separate hits damage a wire and its back-up, as a function of particle diameter.
