MITIGATION OF EMU CUT GLOVE HAZARD FROM MICROMETEOROID AND ORBITAL DEBRIS IMPACTS ON ISS HANDRAILS

ABSTRACT

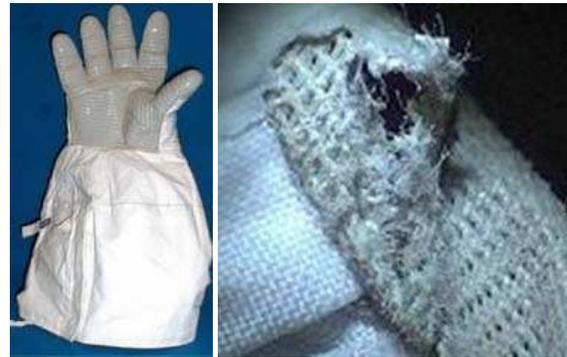
During post-flight processing of STS-116, damage to crewmember Robert Curbeam's Phase VI Glove Thermal Micrometeoroid Garment was discovered (shown in Figure 1). This damage consisted of: loss of RTV-157 palm pads on the thumb area on the right glove and a 0.75 inch cut in the Vectran adjacent to the seam and thumb pad (single event cut), constituting the worst glove damage ever recorded in "the history of going EVA for the U.S. program" [1]. The underlying bladder and restraint were found not be damaged. Evaluation of glove damage showed that the outer Vectran fibers were sliced as a result of contact with a sharp edge or pinch point rather than general wear or abrasion (commonly observed on the RTV pads). Damage to gloves was also noted on STS-118 [2] and STS-120 [3]. A potential source of EMU glove cut hazard is micrometeoroid and orbital debris (MMOD) impact craters on ISS handrails. Returned flight surfaces (see e.g. nitrogen tank assembly handrail in Figure 2) have demonstrated the susceptibility of these structures to regular MMOD impacts.

Figure 1. Damage to crewmember Curbeam's Phase IV glove following EVA 3 of STS-116

Redesign efforts are currently underway to enhance the resiliency of EMU gloves to cut hazards. In the meantime, temporary reinforcements (TurtleSkin® patches) have been added to high wear areas (lower part of thumb and upper part of index finger). Parallel efforts have been made to characterize MMOD impact damage profiles on representative and actual ISS flight hardware and mitigate the cut hazard posed by these profiles on crewmember EMU gloves. In this paper, the results of these characterization and mitigation impact test studies are presented and suggestions for modifications to ground equipment yet to be flown are made.

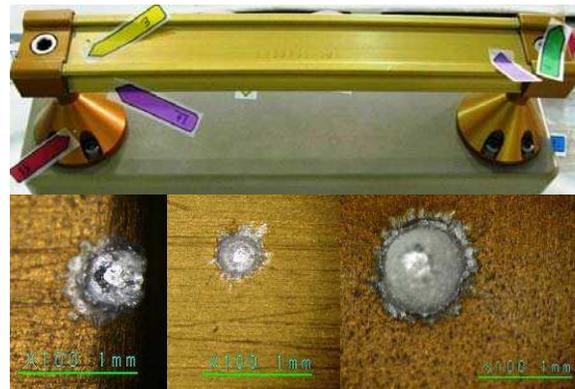
Figure 2. MMOD impacts on the returned nitrogen tank assembly handrail. Top: location of impacts; Below: impact craters 4, 5, 15 (left-to-right)

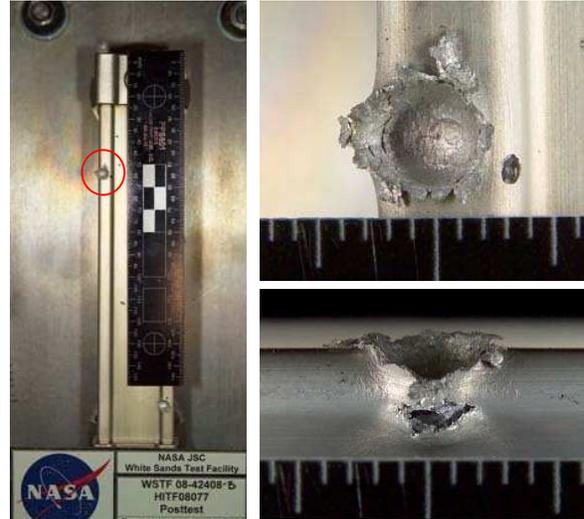
Figure 5: Impact damage on a rectangular ISS handrail induced by impact of a 0.10 cm diameter Al2017-T4 sphere at 6.94 km/s with oblique (45°) incidence

For the rectangular handrail configuration, typical entry hole diameters were 3-4 times that of the projectile

diameter. The damage profiles exhibited protruding crater lips in all cases, with a maximum height of 2.7 mm for impact of a 1.5 mm diameter Al2017-T4 sphere at 6.86 km/s with oblique (45°) incidence (HITF08086). For this test, the projectile impacted upon the thickened corner section of the rectangular handrail. Impacts upon thicker sections of the handrail commonly resulted in damage profiles with more hazardous (i.e. higher) crater lip formations. Generally, it was observed that an increase in projectile diameter leads to an increase in the height of the protruding crater lip. For impacts causing damage to the rear side of the impacted structure (i.e. perforation or spallation), damage features were also characterized. A maximum lip height of 4.6 mm was measured following impact of a 1.8 mm projectile at 7.06 km/s at oblique (45°) incidence on the center of the handrail upper surface.

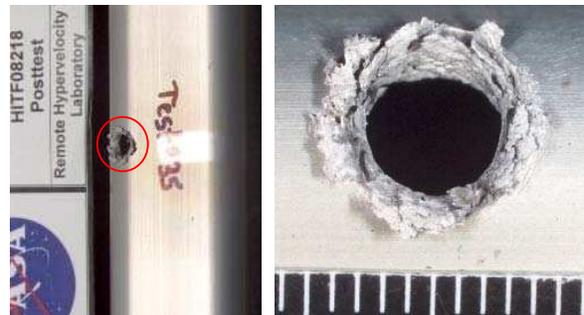
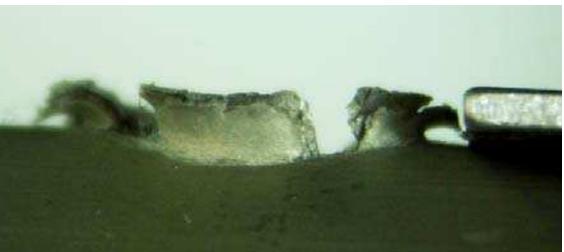
Figure 6: Impact damage on a tubular ISS handrail induced by impact of a 0.15 cm diameter Al2017-T4 sphere at 6.95 km/s with normal (0°) incidence

For the tubular handrail configuration, entry hole diameters were also commonly 3-4 times the diameter of the projectile. However, impact crater lips did not protrude above the handrail surface as much as on the rectangular configuration. The more hazardous crater profiles on the rectangular handrail were found upon the thicker sections. Thus, damage profiles on the thin tubular handrails were not expected to protrude as significantly as on the reinforced sections of their rectangular counterparts. A maximum raised crater lip of 1.9 mm was measured for the tubular handrail, induced by impact of a 1.5 mm diameter Al2017-T4 sphere at 6.95 km/s with normal incidence. None of the 12 impact tests on the tubular handrail resulted in ejection of material from the rear side of the handrail target.

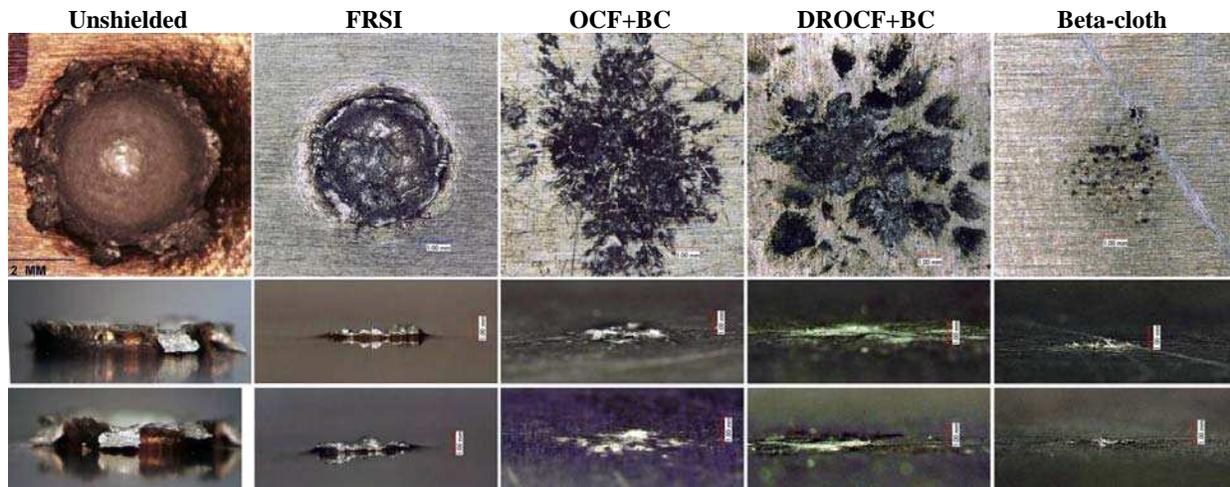
Normal impact of a 1.0 mm diameter Al2017-T4 sphere at ~6.8 km/s on the baseline Al6061-T6 target induced a 4.2 mm diameter crater with a maximum depth of 2.2 mm and a lip that protruded a maximum of 1.0 mm above the target surface. At nominally identical test conditions, all four overwrap configurations were able

to reduce the diameter, depth and protruding lip height of the baseline target crater. A comparison between the impact generated crater in the unshielded handrail and the handrails covered by flexible overwraps is given in Figure 7. The impact crater in the unshielded handrail target is clearly defined, with a well formed lip protruding above the plate surface. Of the overwrap configurations, only the FRSI target shows a clearly formed crater with a discernable lip. The OCF+BC target shows multiple small craters with minimally-protruding lips, while the DROCF+BC and Beta-cloth target damages are limited to discoloration and shallow denting.

Figure 7: Comparison of impact crater profile in an unshielded ISS handrail-representative Al6061-T6 plate and overwrap-shielded plates impacted at normal incidence by a 1.0 mm diameter Al2017-T4 sphere at 6.77 ± 0.22 km/s

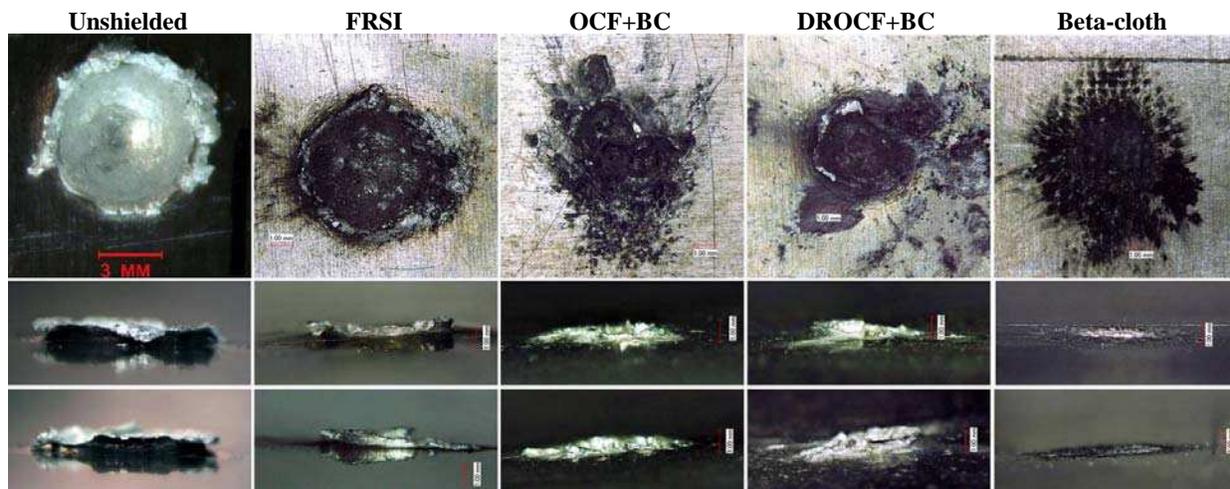
For the oblique impact tests, a crater was formed in the baseline Al6061-T6 target with a diameter of 6.9 mm (maximum), a depth of 2.9 mm, and a maximum raised lip height of 0.8 mm. Similar to the normal impact tests, all four overwrap configurations were effective at reducing the height of the crater lip. In Figure 8 the FRSI target shows a cleanly formed crater with a protruding lip (smaller dimensions than the unshielded target). The OCF+BC target shows multiple overlapping craters, suggesting the projectile was fragmented upon impact with the beta-cloth cover. Although the craters are cleanly formed, there is minimal protrusion of material above the target surface. A similar damage profile is observed on the DROCF+BC target, which shows a single crater cleanly formed with reduced depth, diameter, and raised lip height than the unshielded target. The target plate shielded by the Beta-cloth overwrap shows discoloration and a minimal amount of mechanical damage.

Figure 8: Comparison of impact crater profile in an unshielded ISS handrail-representative Al6061-T6 plate and overwrap-shielded plates impacted at 45° by a 1.5 mm diameter Al2017-T4 sphere at 6.94 ± 0.09 km/s

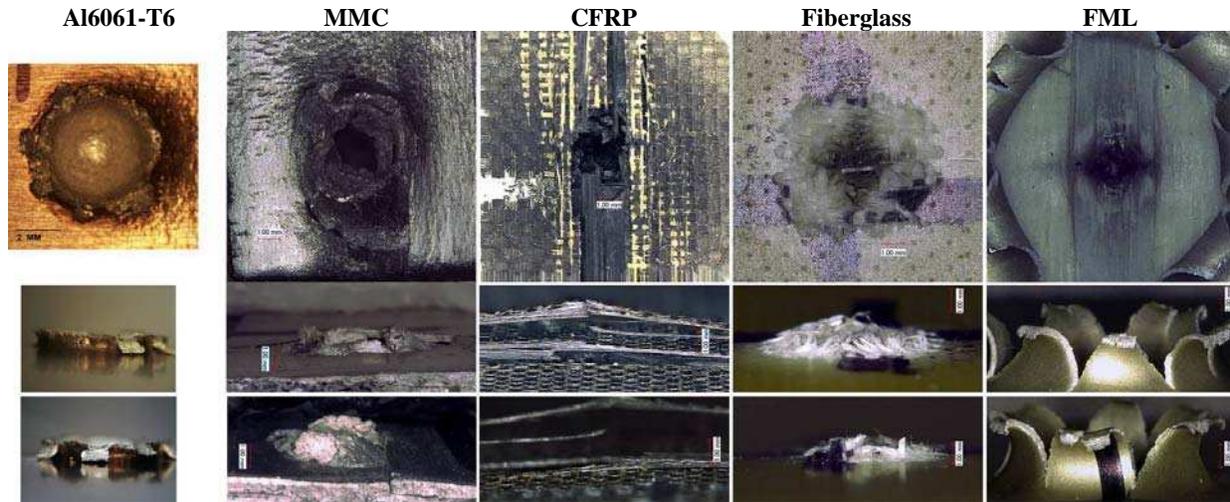
One impact tests was performed on each of the four alternate handrail material targets. A summary of test impact conditions and target damage measurements is given in Table 2. Of the four alternate materials tested, two were found to reduce the height of protruding crater lips (compared to the baseline Al6061-T6 target) for the impact conditions considered, as shown in Figure 9. There was no measurable crater lip on the CFRP target, however there was a large amount of surface spallation about the impact site, including groups of rigid unidirectional fibers that are considered to pose a puncture risk. The outer fabric layer on the CFRP laminate is used to limit the amount of surface spallation; however it is shown that multiple layers may be required to prevent spallation of puncture-hazardous material. The other material to reduce the height of the crater lip was the NP500CR fibreglass. For this

material, the area about the impact site contained fractured and delaminated glass fibers. Although protrusions extending above the target surface, these protrusions were not rigid, nor did they extend beyond the local impact site (see Figure 9). Unlike the CFRP, the epoxy has been completely removed from the protruding glass fibers and, as such, they are considered to pose minimal puncture risk. The GLARE fiber metal laminate had the highest crater lip, ~ 3.3 times that of the baseline aluminium alloy. In Figure 9 it can be observed that the outer aluminium layer of the FML peeled back from the composite layer, resulting in a large crater diameter with sharp petalled edges. Having a number of glass/epoxy composite layers on the outer surface of the laminate (instead of an aluminium alloy layer) may reduce the protrusion height of the crater lip. The Nextel 610/pure aluminium metal matrix composite provided a similar

Figure 9: Comparison of impact crater profile in a simulated ISS handrail and alternate handrail materials impacted by a 1.0 mm diameter Al2017-T4 sphere at 6.91 ± 0.08 km/s with normal incidence (0°)

lip height to that of the baseline aluminium alloy. The outer layer of the MMC laminate is seen to have fractured about the impact site, resulting in minimal protrusion above the target surface. However, the second layer did not fracture in a similar manner, resulting in a 1.0 mm measured lip height. The MMC target was penetrated by the projectile, forming an exit hole that was raised 2.45 mm above the rear target rear side. Although the thickness of the MMC laminate was less than the baseline material, penetrating impacts on Al6061-T6 with larger projectiles resulted in rear side damage features less hazardous than that of the MMC. As such, the performance of the MMC is considered worse than the baseline aluminium alloy.
