# MICROMETEOROID AND ORBITAL DEBRIS THREAT MITIGATION TECHNIQUES FOR THE SPACE SHUTTLE ORBITER

## ABSTRACT

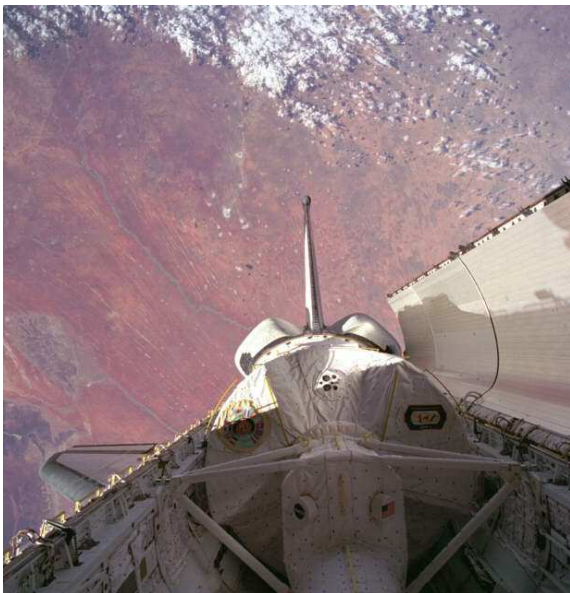
The 16 day STS-73 mission in 1995 carried a United States Microgravity Module (USML) Spacelab module and an EDO cryogenics pallet in the payload bay. The vehicle was oriented with its port wing into the velocity vector for 13 days of the mission, so the port payload door was kept partially closed in order to protect the USML and EDO payloads from MMOD impacts. Post flight inspections revealed a crater in the outside surface of the port payload bay door that was 17 mm in diameter and 6 mm deep. A 1.2 mm long intact fragment of a circuit board was found in the crater [6]. If this orbital debris projectile had impacted a different region of the orbiter, such as the EDO pallet or a wing leading edge RCC panel, it could have caused the loss of the vehicle and crew.

Figure 1. Shuttle Columbia payload bay (STS-73)

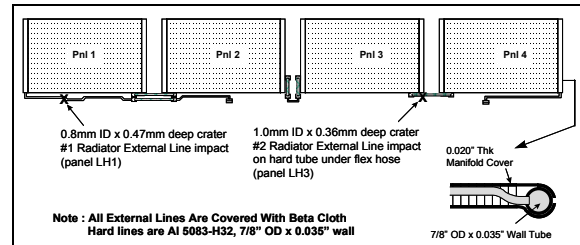
After the STS-86 mission in 1997, several significant MMOD impacts were observed on the left hand radiator interconnect lines (Fig. 2). The aluminum tubes carry Freon coolant between the thermal control system radiator panels.

Figure 2. Impacts on STS-86 LH radiator interconnect lines.

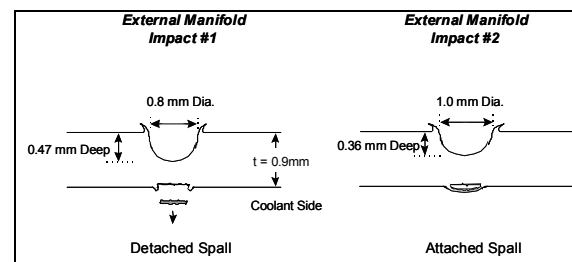
Figure 3. Impacts on STS-86 radiator interconnect lines.

The largest impact, on the external line at panel #1, penetrated just over halfway through the 0.9 mm wall thick coolant tube wall [6]. Post flight inspections determined that the site experienced detached spall on the inside surface of the tube wall, close to a tube perforation (Fig. 3). A tube leak would likely have resulted in a mission abort and possible loss of mission objectives. Post flight analysis indicated that impact #1 was caused by an orbital debris particle of stainless steel, while impact #2 was produced by a micrometeoroid particle. After this mission, an additional layer of beta cloth was added to the external radiator lines on all orbiters [6].

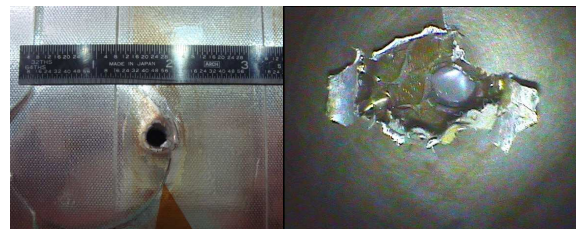
Figure 4. MMOD impacts on STS-118 LH4 radiator.

The STS-118 mission in 2007 experienced a large MMOD impact on the left hand #4 radiator. The impact produced a 5.5 mm diameter entry hole in the thermal tape and outer face sheet of the aluminum sandwich panel (Fig. 4). Subsequent inspections revealed a 12 mm

x 19 mm exit hole in the inner face sheet of the radiator panel, with two small down stream damage sites on a thermal control system (TCS) blanket under the radiator. The payload bay door under the TCS blanket was not damaged by the impact. Analysis showed that this impact was caused by an orbital debris particle that was rich in Titanium, Zinc and Antimony.
