Surveys of Returned ISS Hardware for MMOD Impacts

Hyde, J.L.⁽¹⁾, Christiansen, E.L.⁽²⁾, Lear, D.M.⁽³⁾, Nagy, K.⁽⁴⁾, Berger, E.L.⁽⁵⁾

1 PMA-2 COVER

5 AIRLOCK SHIELD PANELS

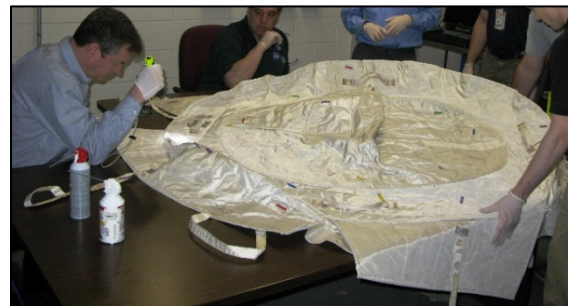
Figure 2. PMA-2 cover inspection

Fig. 2 shows the inspection of the PMA-2 cover at JSC. The circular blanket was approximately 2 meters in diameter with a 0.20 mm thick beta cloth (silica fiber) outer cover. Also inspected were nine beta cloth straps that were used to hold the cover in place on the PMA. The inspection was performed in three steps. An initial screening was performed on all space exposed surfaces with 15X handheld magnifiers, with 34 areas of interest marked for further study. In the second step each area of interest was examined with a handheld 25X-200X microscope enabling a more detailed characterization. 26 sites were observed with distinct hypervelocity impact features and 8 sites were judged to be non-MMOD. Fig. 3 shows feature #1 from Tab.1 as typical MMOD impact damage observed during the inspection. The final inspection step involved a boom mounted digital microscope that allowed precise measurements of the entry hole.

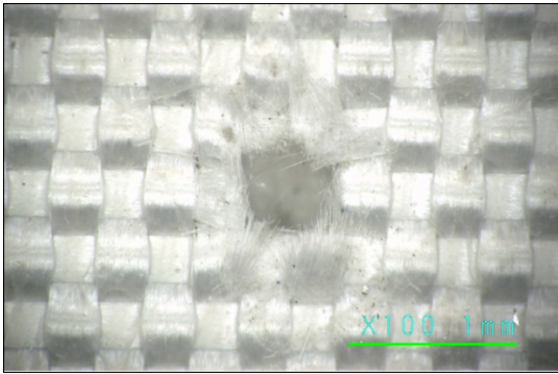
Damage sizes on the beta cloth outer surface of the cover and the hold-down straps ranged from just over 1mm to 0.13mm in diameter.

Figure 3. Typical impact damage on PMA-2 cover

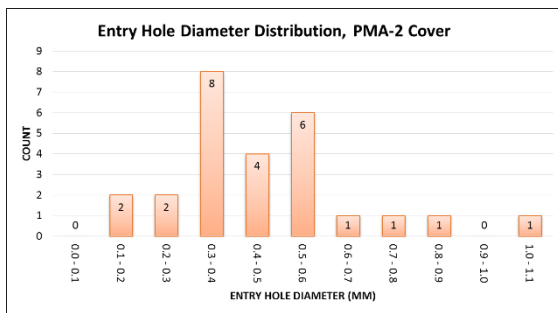
Figure 4. Distribution of PMA-2 entry hole sizes

Eq. 1 results in a circular area with the same area as the measured hole assuming elliptical geometry for the hole. Calculated entry hole diameters are provided in Tab. 1. It can be seen in the distribution of entry hole diameters (Fig. 4) that feature sizes in the 0.3 to 0.6 mm range were the most common. The mean value of the 26 observations was 0.45 mm.

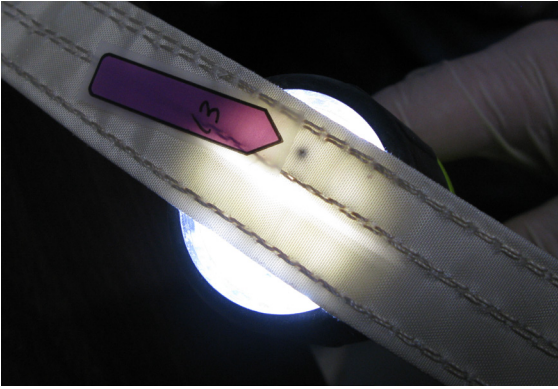
An example of the scanning electron microscopy used to determine the nature of the impactors on the PMA-2 cover is provided for impact #13, observed on one of the tie down straps. The impact area is backlit in Fig. 5, highlighting the extent of the subsurface damage. The impact event melted both the projectile and the beta cloth target (Figs. 6-7). Analysis by scanning electron microscope indicated this damage was due to a micrometeoroid impactor rich in iron, nickel and sulfur.

Figure 5. Impact in PMA-2 cover tie down strap

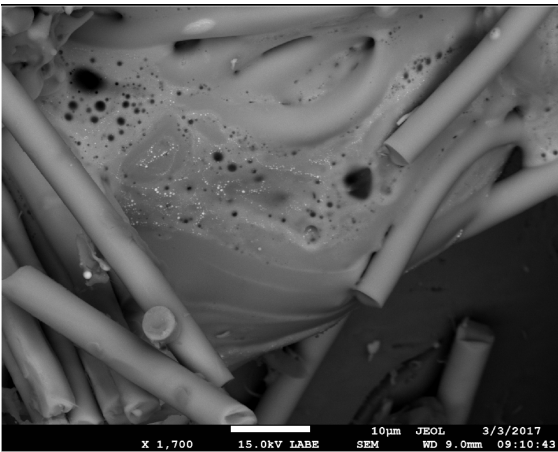
Figure 6. Impactor melt flow around beta cloth fibers

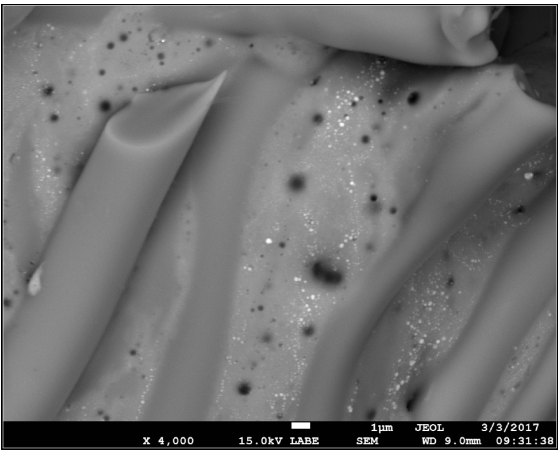
Figure 7. Close-up image of impactor melt droplets

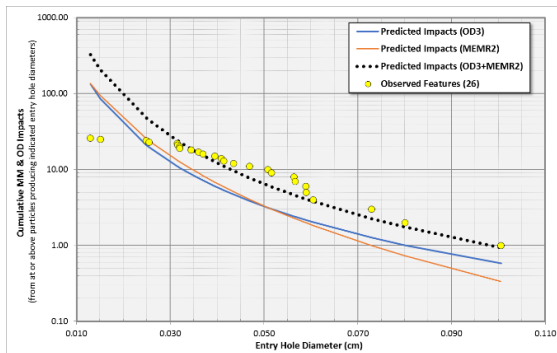
Fig. 9 compares the observed entry hole diameters on the PMA-2 cover with Bumper 3 predictions for the expected number of impacts from ORDEM 3.0 and MEMR2. Observations below 0.03 cm show typical roll-off at the small end of MMOD inspection data sets, due to the difficulty in finding small impact features (i.e., sensor/observation limitations).

Figure 9. Comparison of 26 estimated particle sizes causing observed damage on the PMA-2 cover and Bumper 3 predictions

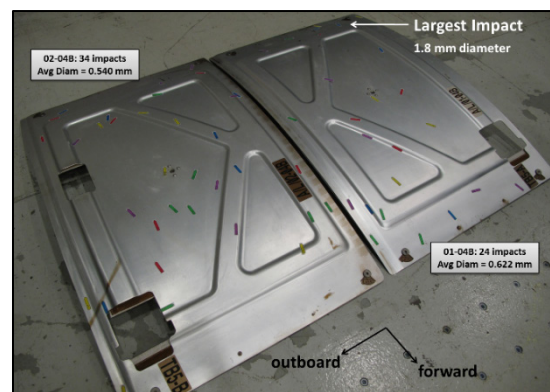
The airlock shield panels are made of aluminum 6061-T6 and are each 1.3 m long, 0.84 m wide and 0.2 cm thick. The survey of these panels was limited to a visual inspection with additional characterization by handheld digital microscope. Craters less than 0.25 mm diameter were not recorded. The inspection measured the “inside diameter” of the crater, recorded at the original height of the panel surface. A total of 58 craters were observed, 34 on the outboard panel and 24 on the inboard. The inspected shield panels can be seen in Fig. 11 with the 58 regions of interest flagged (colored arrows). 56 of the 58 observed craters were nearly circular, with only two elliptical craters recorded. The largest circular impact crater (Fig. 12) measured 1.8 mm in diameter.

Figure 11. Inspection results on airlock shields

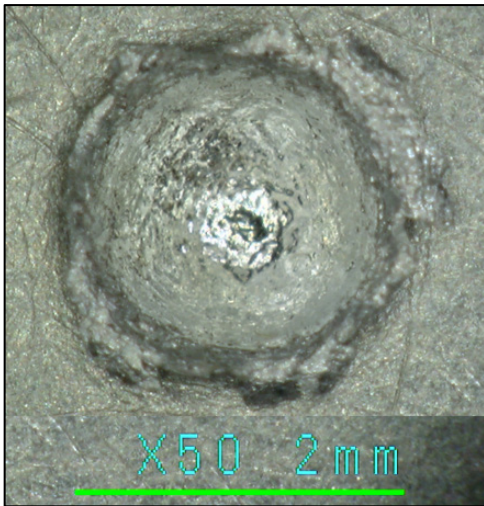
Figure 12. 1.8 mm impact crater on airlock panel

This impact produced a 2 mm diameter bulge on the backside of the 2.03 mm shield panel. An elliptical crater measuring 2.4 x 0.9 mm (Fig. 13) was observed on the same panel.

Crater 33-1 is shown in Fig. 12. An extracted sample from the crater with the associated SEM image and spectra are given in Fig. 17. This sample along with many others appeared to have silica melted into the aluminium.

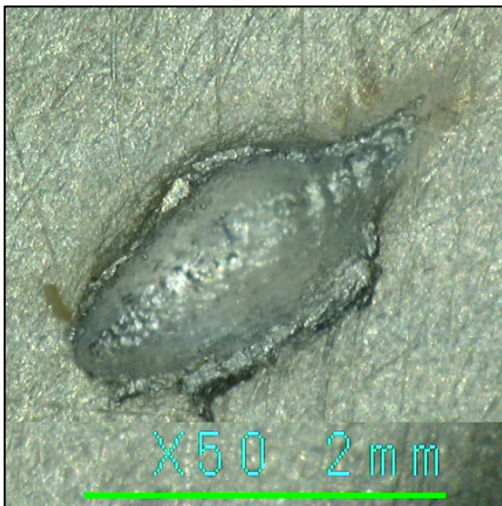
Figure 13. 2.4 x 0.9 mm impact crater on airlock panel

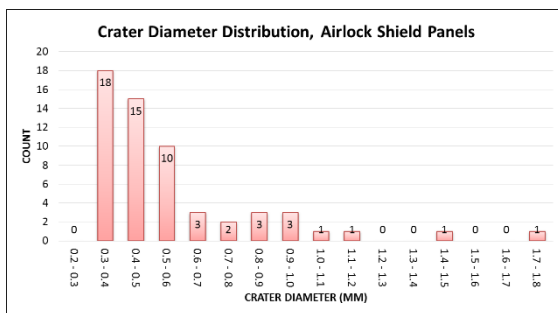
An equivalent circular crater size was calculated from measured dimensions using Eq. 1 and the crater diameter distribution is given in Fig. 14.

Figure 14. Distribution of airlock crater diameters

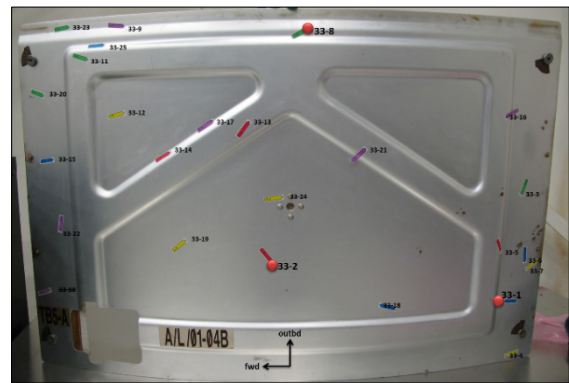
Figure 15. 24 craters on airlock shield 01-04B, sampled craters highlighted with red circles

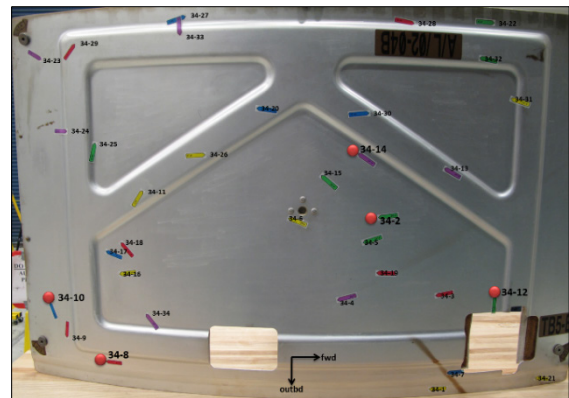
Figure 16. 34 craters on airlock shield 02-04B, sampled craters highlighted with red circles

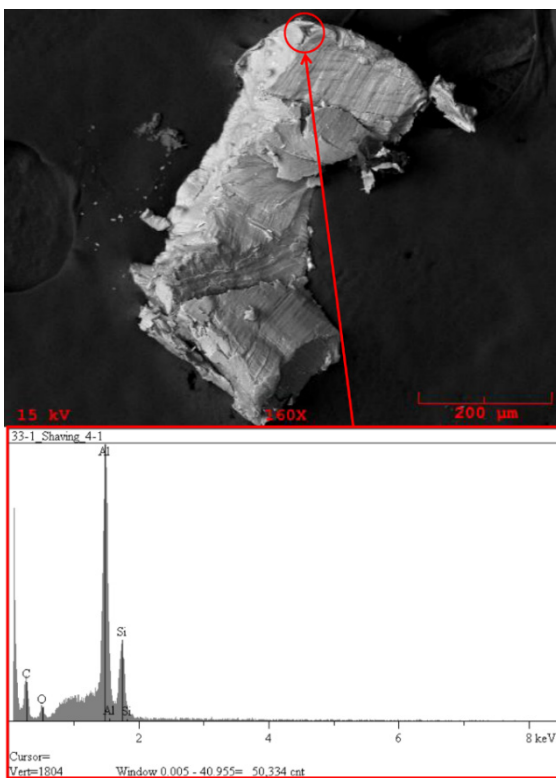
Figure 17. SEM results of sample from crater 33-1 indicate trace silica melt in the aluminum

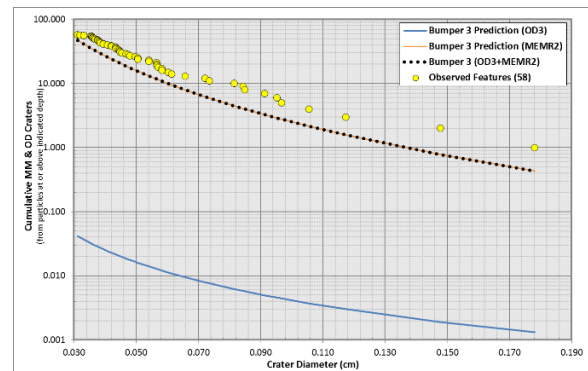
All 58 observed craters are compared with ORDEM 3 and MEMR2 in Fig. 19. Bumper 3 predicts nearly all ($\geq 99.7\%$) of the craters are from micrometeoroids. The predicted number of MMOD impacts was higher than observed. The explanation for this is that there were more orbital debris impacts observed and very little orbital debris was predicted to hit these panels because their location on ISS should have prevented orbital debris from impacting them. We believe the likely explanation for this discrepancy is that the orbital debris found on the airlock panels was due to secondary debris (ejecta or penetration products) produced by MMOD impacts on the ISS radiators and solar arrays. The composition of the OD particles determined by SEM analysis supports this hypothesis, with many of the craters containing silica (potentially from solar arrays) and paint (possibly from radiators).

Figure 19. Comparison of Bumper 3 predictions using ORDEM 3 and MEMR2 to all observed MMOD impacts

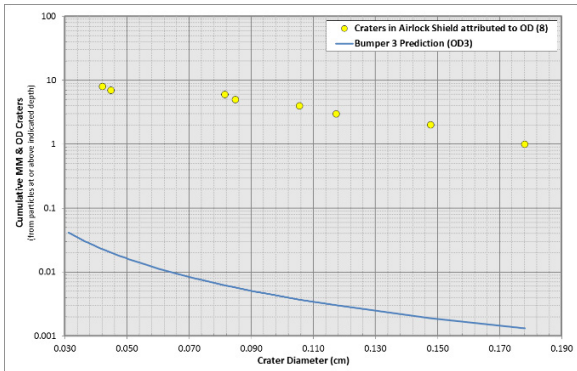
8 of the 9 samples that were analyzed produced indications of orbital debris. The 8 observed craters attributed to orbital debris are compared to ORDEM 3 predictions in Fig. 20. The predicted number of craters from orbital debris is very small compared to micrometeoroids due to the orientation of the shield panels on the zenith/aft facing region of the airlock.

Figure 20. Comparison of Bumper 3 predictions using ORDEM 3 to impacts attributed to orbital debris
