# VULNERABILITY OF SPACECRAFT NICKEL-CADMIUM BATTERIES TO HYPERVELOCITY IMPACTS

Robin Putzar<sup>(1)</sup> and Frank Schäfer<sup>(2)</sup>

## ABSTRACT

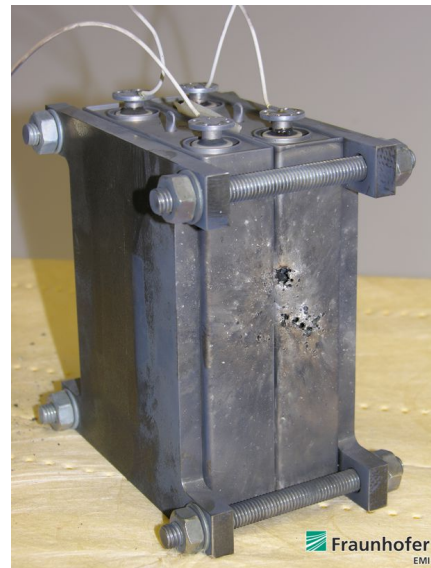
Figure 1. Nickel cadmium battery cell after hypervelocity impact (exp. 4763).

In exp. 4763, cell 1 was perforated with ca. 21 holes. The size of the largest hole in cell 1 was 1.5 × 2.0 mm. Cell 2 was perforated with approx. 25 holes. The size of the largest perforation hole in cell 2 was 14 mm × 9 mm. The function of cell 1 was nominal during and up to one hour after impact testing. Cell 2 failed during the test; the cell voltage dropped to half its original value within 6.3 s. The cell lost its entire capacity within 120 seconds after the impact. The voltage of both cells dropped during the initial 250  $\mu$ s after the impact by approx. 250 mV.

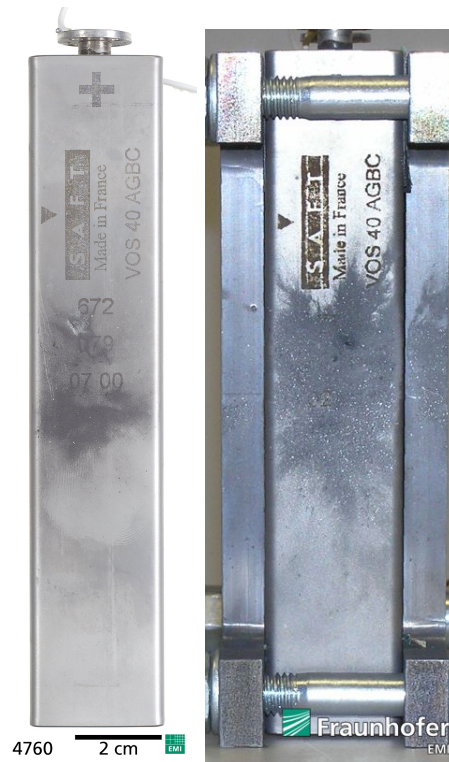
In exp. 4760, the battery cell wall was not perforated. The depth of the deepest crater was 1.1 mm. The battery cell function was nominal during and up to one hour after impact testing.

In exp. 4761, the battery cell wall was perforated. There were two holes. The size of the largest hole was ca.  $1.1 \pm 0.2$  mm in diameter. The battery cell function was nominal during and up to one hour after impact testing.

Figure 9. Mechanical damage to battery front side in experiments 4760 (left) and 4761 (right).

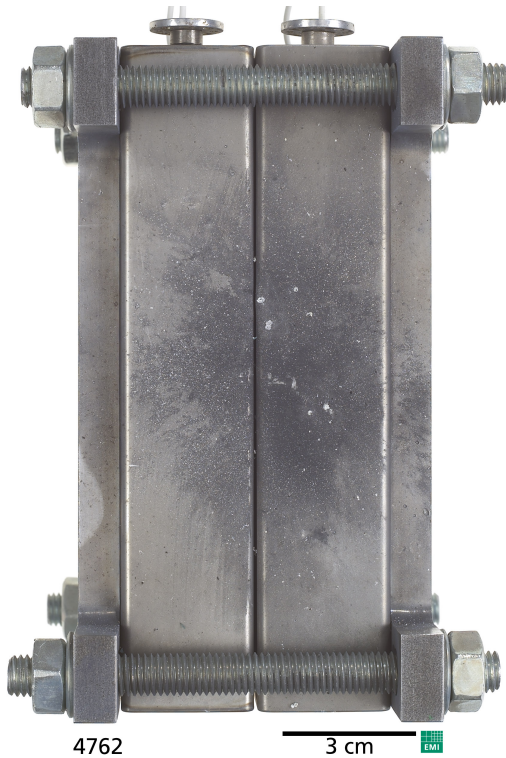
In exp. 4762, cell 1 was not perforated. The depth of the deepest crater in cell 1 was 0.4 mm. Cell 2 was perforated. The size of the largest hole in cell 2 was  $0.7 \pm 0.2$  mm ×  $0.9 \pm 0.2$  mm. Both cells were functioning nominally during and up to one hour after impact testing.

Figure 10. Mechanical damage to battery front side in experiments 4762.

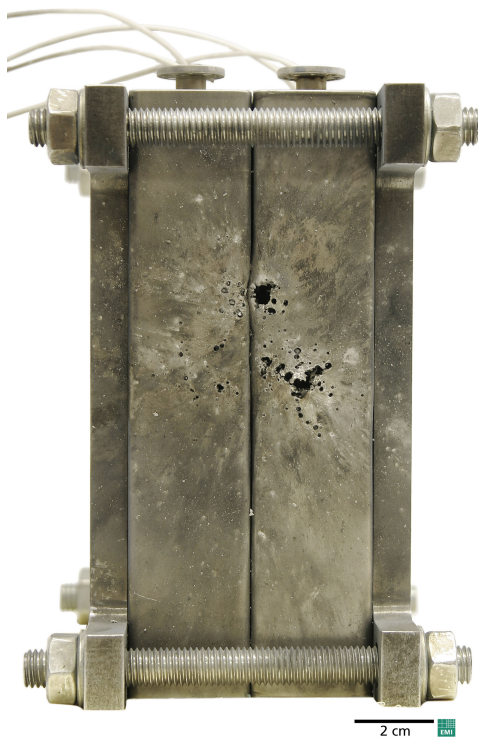
Figure 11. Mechanical damage to battery front side in experiments 4763.

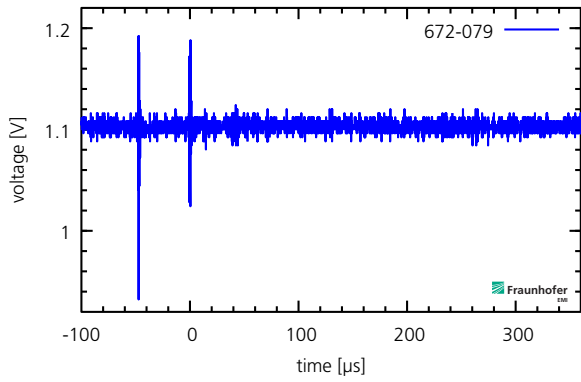
The signals recorded during experiments 4760 and 4761 (figures 12 and 13) show no effect of the impact on the battery voltage during the initial 360  $\mu\text{s}$  after impact. The reason for a peak approx. 88  $\mu\text{s}$  after impact in experiment 4761 is unknown; no correlation between the impact event could be identified. In experiment 4760, the cell voltage remained constant, indicating nominal cell function. In experiment 4761, which caused cell wall perforation, the cell voltage was not altered for at least 60 minutes after the test. This cell was discharged through a resistor at a later stage. During the capacity checks performed during post-impact characterization, it was found that the capacity was not altered measurably, noting however that the level of charging for the post-impact function assessments was just about 10% of the maximum charge the battery can contain. It is assumed that successive full charge-discharge cycles of the cell would lead to complete loss of electrical capacity, because of the catalytic fluid evaporating gradually through the small impact hole from the pressure build-up in the cell in a charged state.

Figure 12. Electrical performance of battery in experiment 4760.

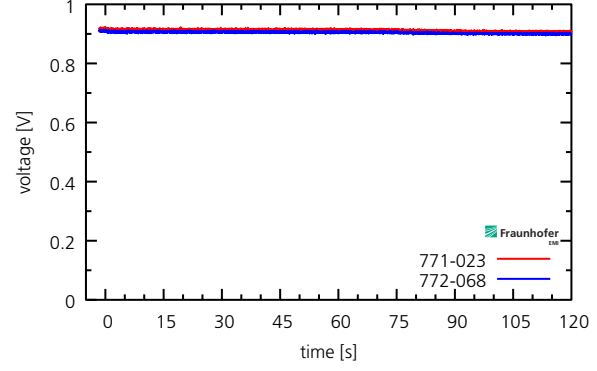
The signals recorded during experiment 4762 (figures 14 and 15) show some effect during impact: a peak at the time the fragment cloud impacts on the battery cells (approx. 30  $\mu\text{s}$  after impact flash trigger). Further, the battery cell that is perforated (no. 772-068), experiences a slight voltage drop of approximately 50 mV (ca. 5% of nominal cell voltage), lasting for a duration of ca. 30  $\mu\text{s}$  almost immediately after the encounter of the fragment cloud on the cell. After this, the voltage remains stable for at least 2 minutes (end of recording time). In post-test characterization of the perforated battery cell it was shown that the capacity decreased just slightly, however, the same comments as for exp. 4761 apply here.

Figure 15. Longer-term electrical performance of batteries in experiment 4762. Cell 1 has serial number 771-023, cell 2 has serial number 772-068.

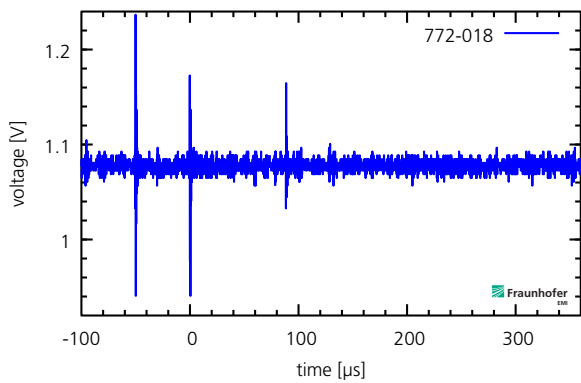
Figure 13. Electrical performance of battery in experiment 4761.

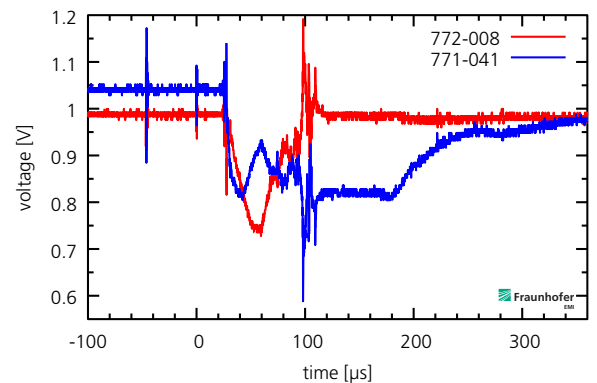
In experiment 4763, the battery cell voltage was significantly affected during impact (see figures 16 and 17). Both cells experience significant voltage drops of up to 50% during the initial 250  $\mu\text{s}$  after the impact (approx. 250 mV for both batteries with approx. 320  $\mu\text{s}$  and 70  $\mu\text{s}$  duration for battery no. 771-041 and 772-008, respectively). The voltage of battery no. 771-041 (the heavily perforated) dropped to half its original value within 6.3s; this cell lost its complete

Figure 16. Electrical performance of batteries in experiment 4763. Cell 1 has serial number 772-008, cell 2 has serial number 771-041.

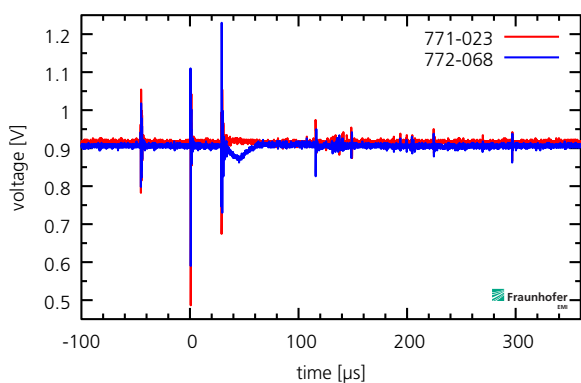
Figure 14. Electrical performance of batteries in experiment 4762. Cell 1 has serial number 771-023, cell 2 has serial number 772-068.

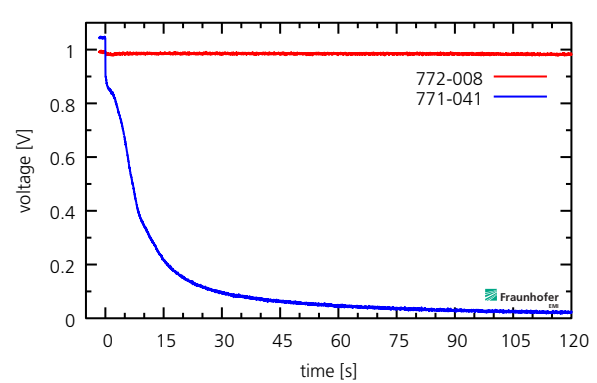
Figure 17. Longer-term electrical performance of batteries in experiment 4763. Cell 1 has serial number 772-008, cell 2 has serial number 771-041.

capacity within 120 seconds after the impact. This indicates a total sudden failure caused by the impact. It is believed that this failure was induced by a short circuit inside the cell, probably due to a large fragment which intruded into the battery. The other cell was analyzed during post-impact characterization of the cell function. As for the other perforated cells it had almost the same residual capacity during the initial charge-discharge cycle compared to before the test, but is expected to fail during subsequent full charge-discharge cycles, see comments above.
