ReSHIFT

Theoretical and Experimental Progress in the understanding of destructive re-entry

4TH INTERNATIONAL WORKSHOP PN SPACE DEBRIS RE-ENTRY, DARMSTADT, 28 FEB – 1 MARCH 2018
PR00011 / D22

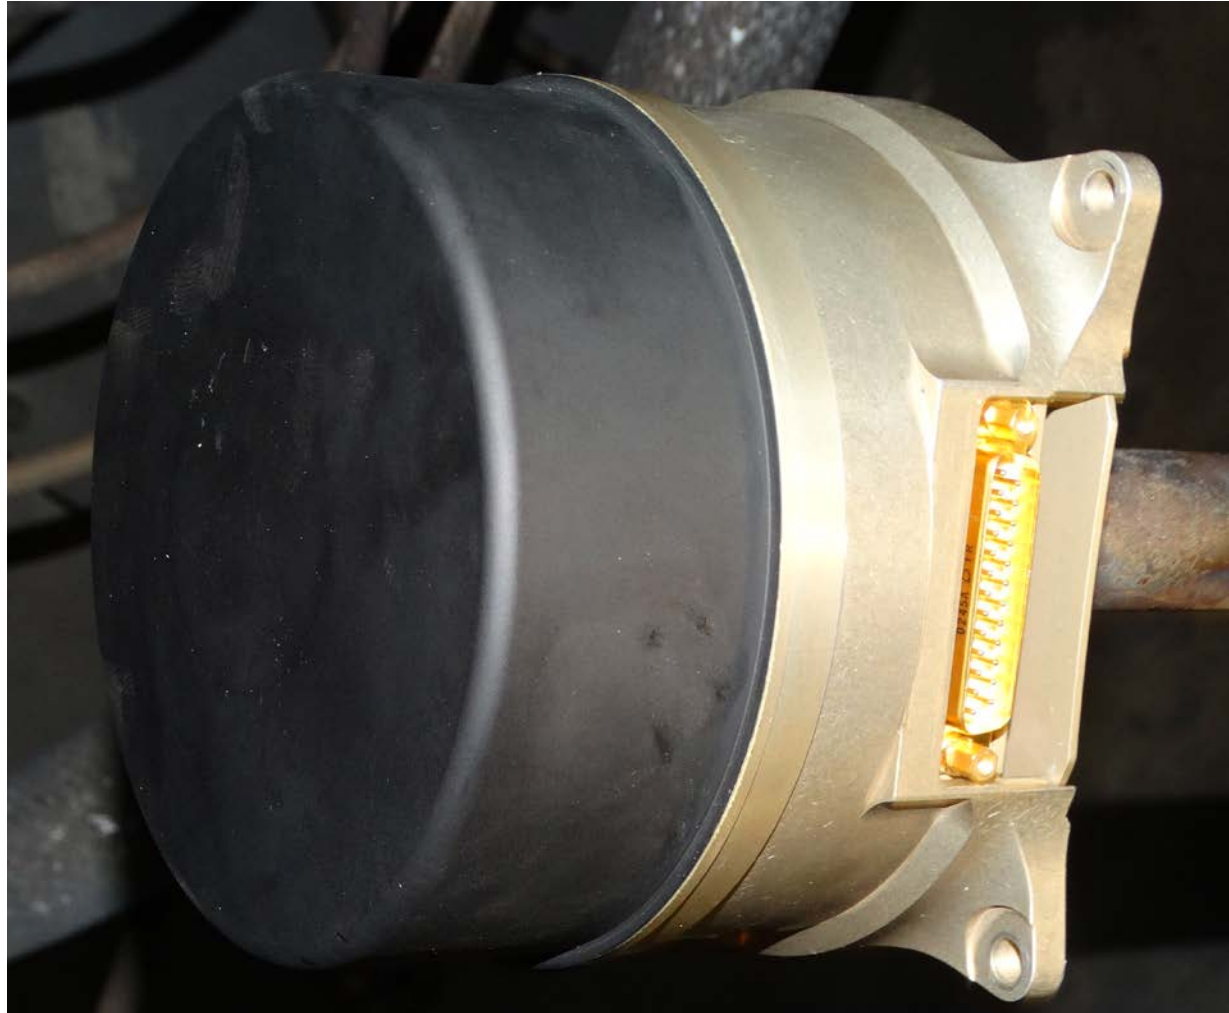
Reaction wheel cover...

- is similar to hat samples (aluminum, thin).
- glued in place.
- painted black for good (infrared) radiation of heat.

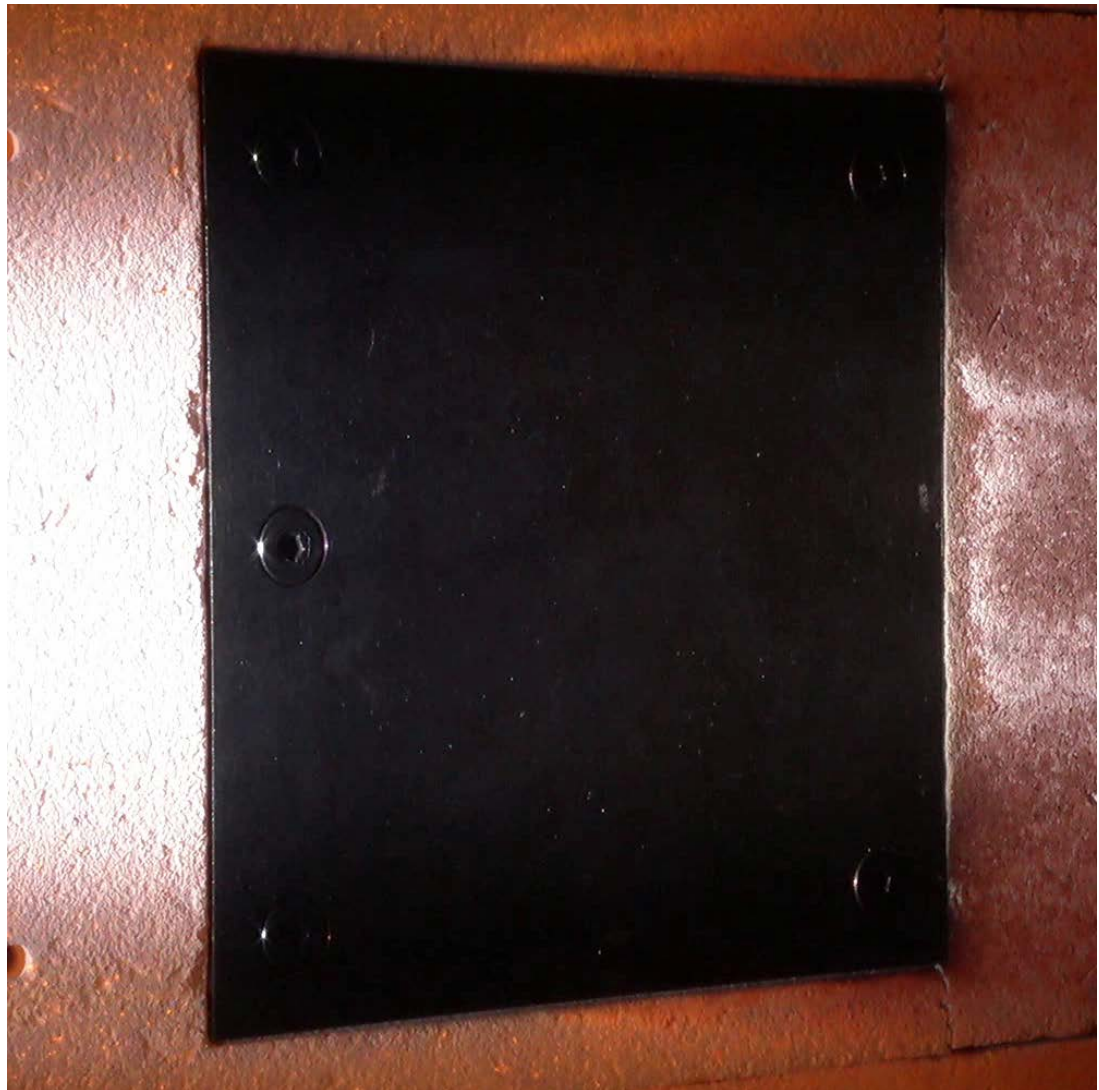
Shear tests show...

- bubble formation on surface when alloy components start vaporizing and
- aggregation of molten aluminum below oxide skin.
- spilling of melt when oxide bag breaks.

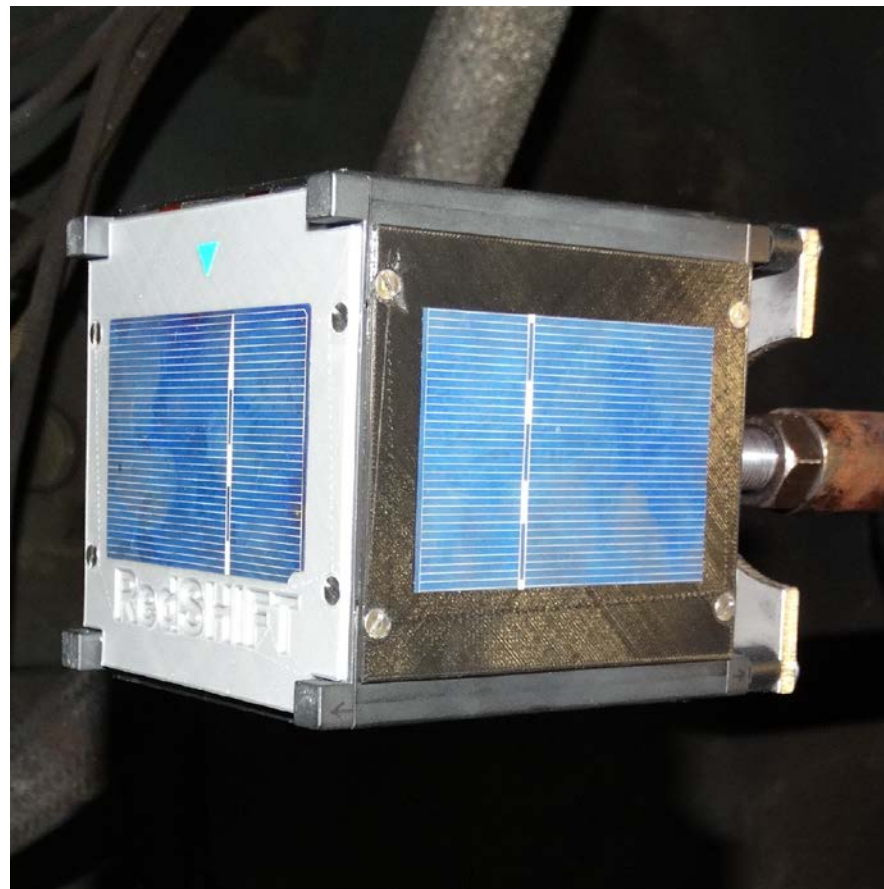
during integration, PCBs exposed

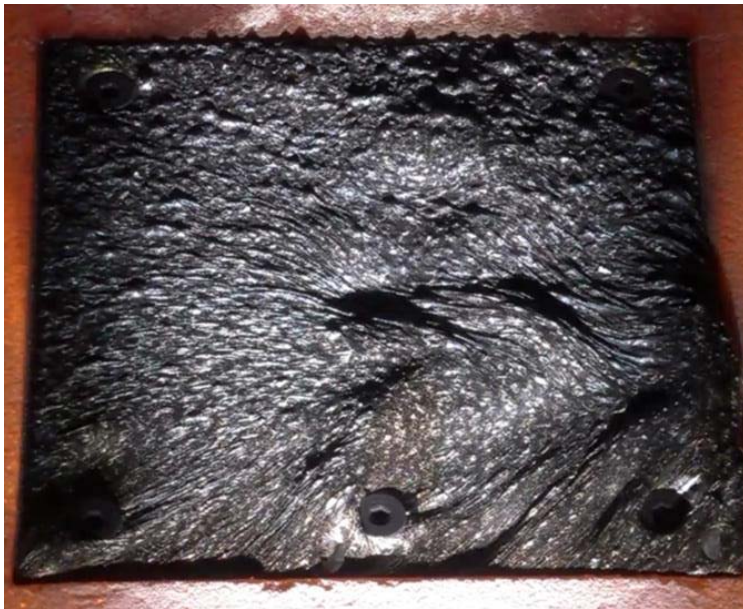
First Complete Satellite Demise Test

- Aluminium structure melts/shears
- Structure supported by threaded steel spacers
- GFRP electronics cards charred, but not molten

First tests of complete satellite

- Structure melts; steel rods for mounting can support structure
- GFRP electronics cards more robust than expected

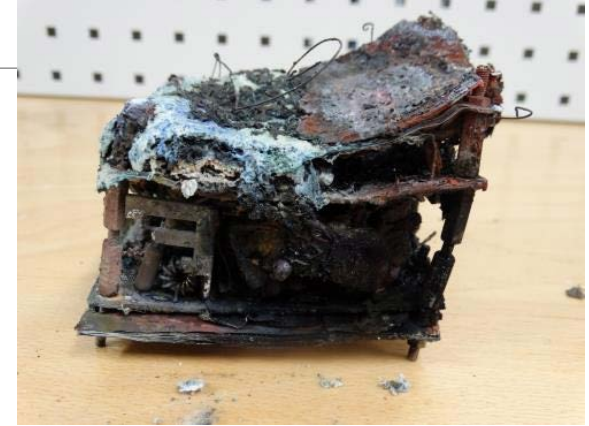
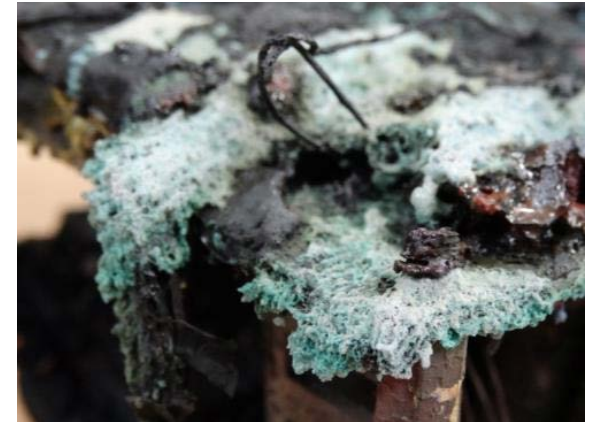
Double Heat Flux

- GFRP cards have melt run-off, but are essentially intact
- Structure is weak, can be expected to break-up
- Some care is needed with electronics cards
 - Much mass is lost; outgassing from electronics
- Heat transfer through CubeSat is slow

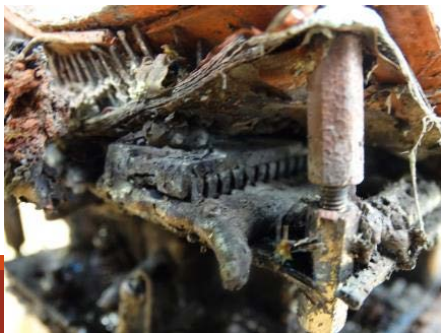
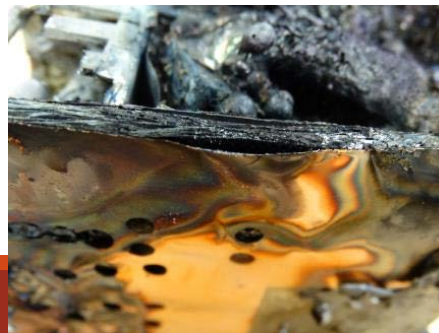
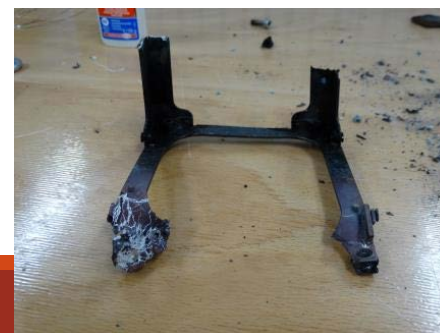
What happens to facesheets?

- Bend, but very resistant to breakage
- Facesheets will survive, perhaps in parts
- Will be very light; no risk expected

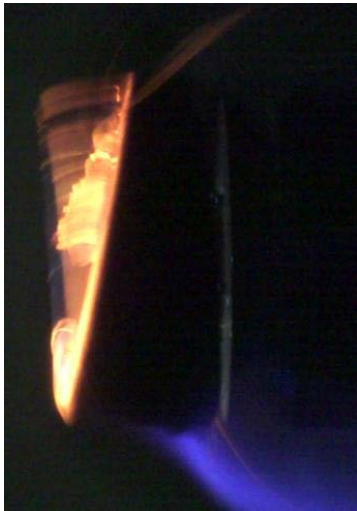
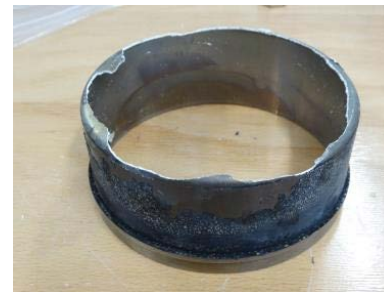
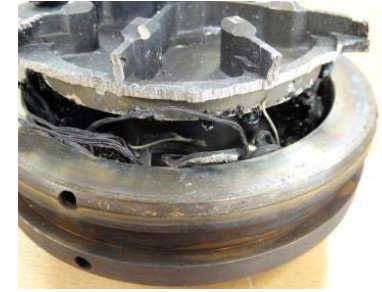
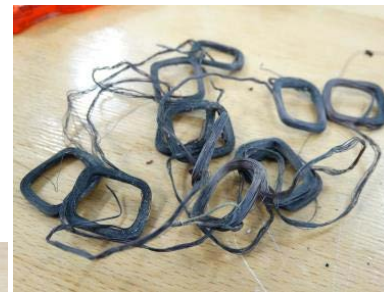
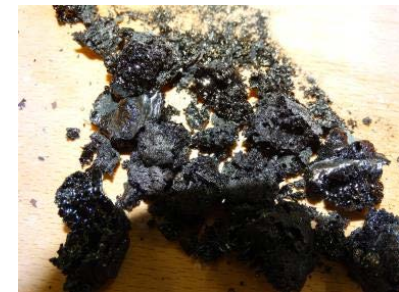
Test of Ball Bearing Unit and Flywheel

- High temperatures on smaller radius central part
- Confirmation that curvature is important
- Some damage before major heat soak
- Radiative Equilibrium Reached ($\sim 800 \text{ kW/m}^2$)
- Temperatures of $1310 \text{ }^\circ\text{C}$ on front surface
- Lower temperatures $\sim 1000 \text{ }^\circ\text{C}$ on flywheel
- Energy Balance Performed
- Equilibrium heat transfer
- Suggests $\sim 10\%$ catalycity; 0.9 emissivity
- Consistent with ESA Materials Characterisation
- Not quite as bad for demise as it looks...
 - Large radiating area; No tumble
 - More work to be done on implications for demise
 - But massive steel objects are clearly an issue

First tests of real spacecraft equipment

- Reaction wheel demise process very different from models
- Many small parts produced
- Heating distribution evident; curvature is clearly important
