## AN EXPERIMENTAL STUDY TO INVESTIGATE HYPERVELOCITY IMPACTS ON PRESSURE VESSELS

F. Schäfer, E. Schneider

Ernst-Mach-Institut - Fraunhofer Institut für Kurzzeitdynamik  
Eckerstr. 4, D-79104 Freiburg

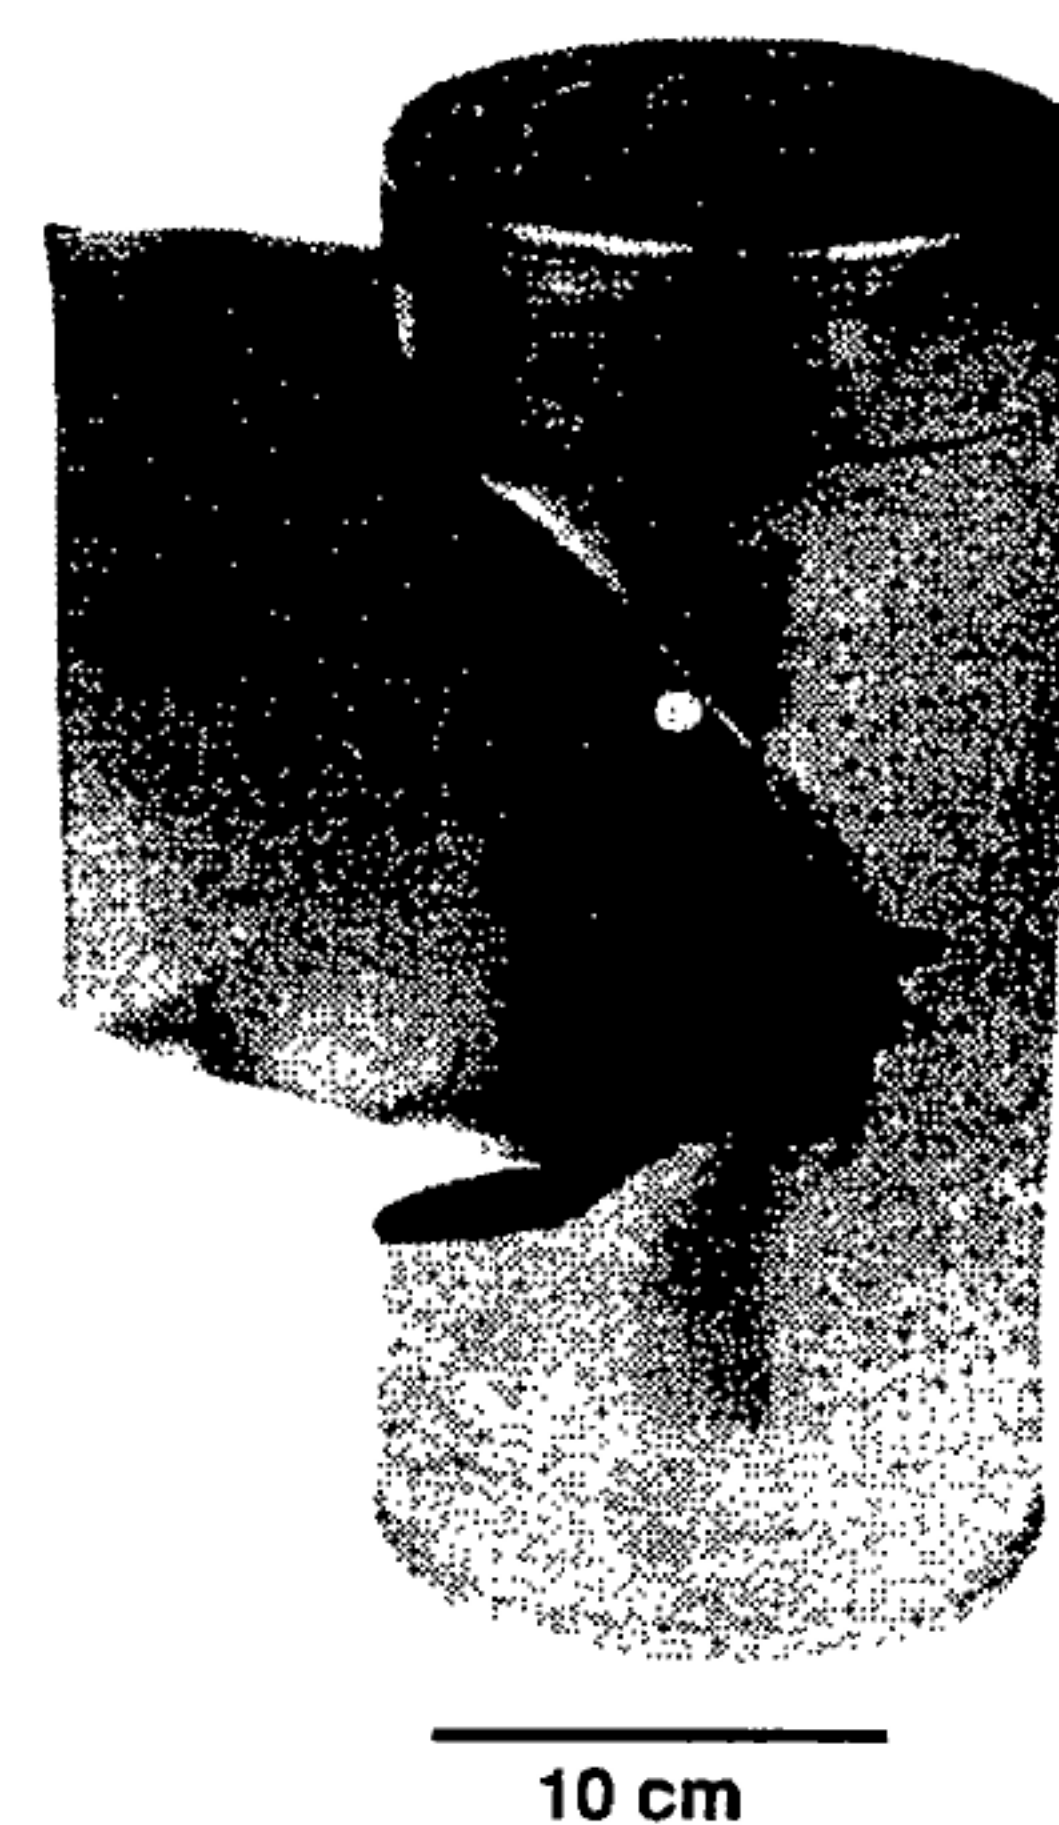
Figure 7. Exp. Al-18 (rear view)  
 $d=4.9$  mm,  $v=6.9$  km/s  
 $p=4.3$  bar,  $\sigma/\sigma_{\max}=0.17$

Increasing wall stress leads to catastrophic rupture at the rear side of the vessel. In Exp. Al-18 (Fig. 7) and Al-19 (Fig. 9), both projectile diameters were 5.0 mm, impacting at roughly 7 km/s. Wall stresses amounted to 0.17 and 0.71. Both vessels failed from the rear side. At a wall stress of 0.17, still traces of impact craters were found, which most likely initiated the cracks. Although two large cracks formed, the vessel stayed in one piece. At a wall stress of 0.71, crack growth was not stopped in the wall, the vessel disintegrated into several pieces. No traces of particle impact on the rear side were found.

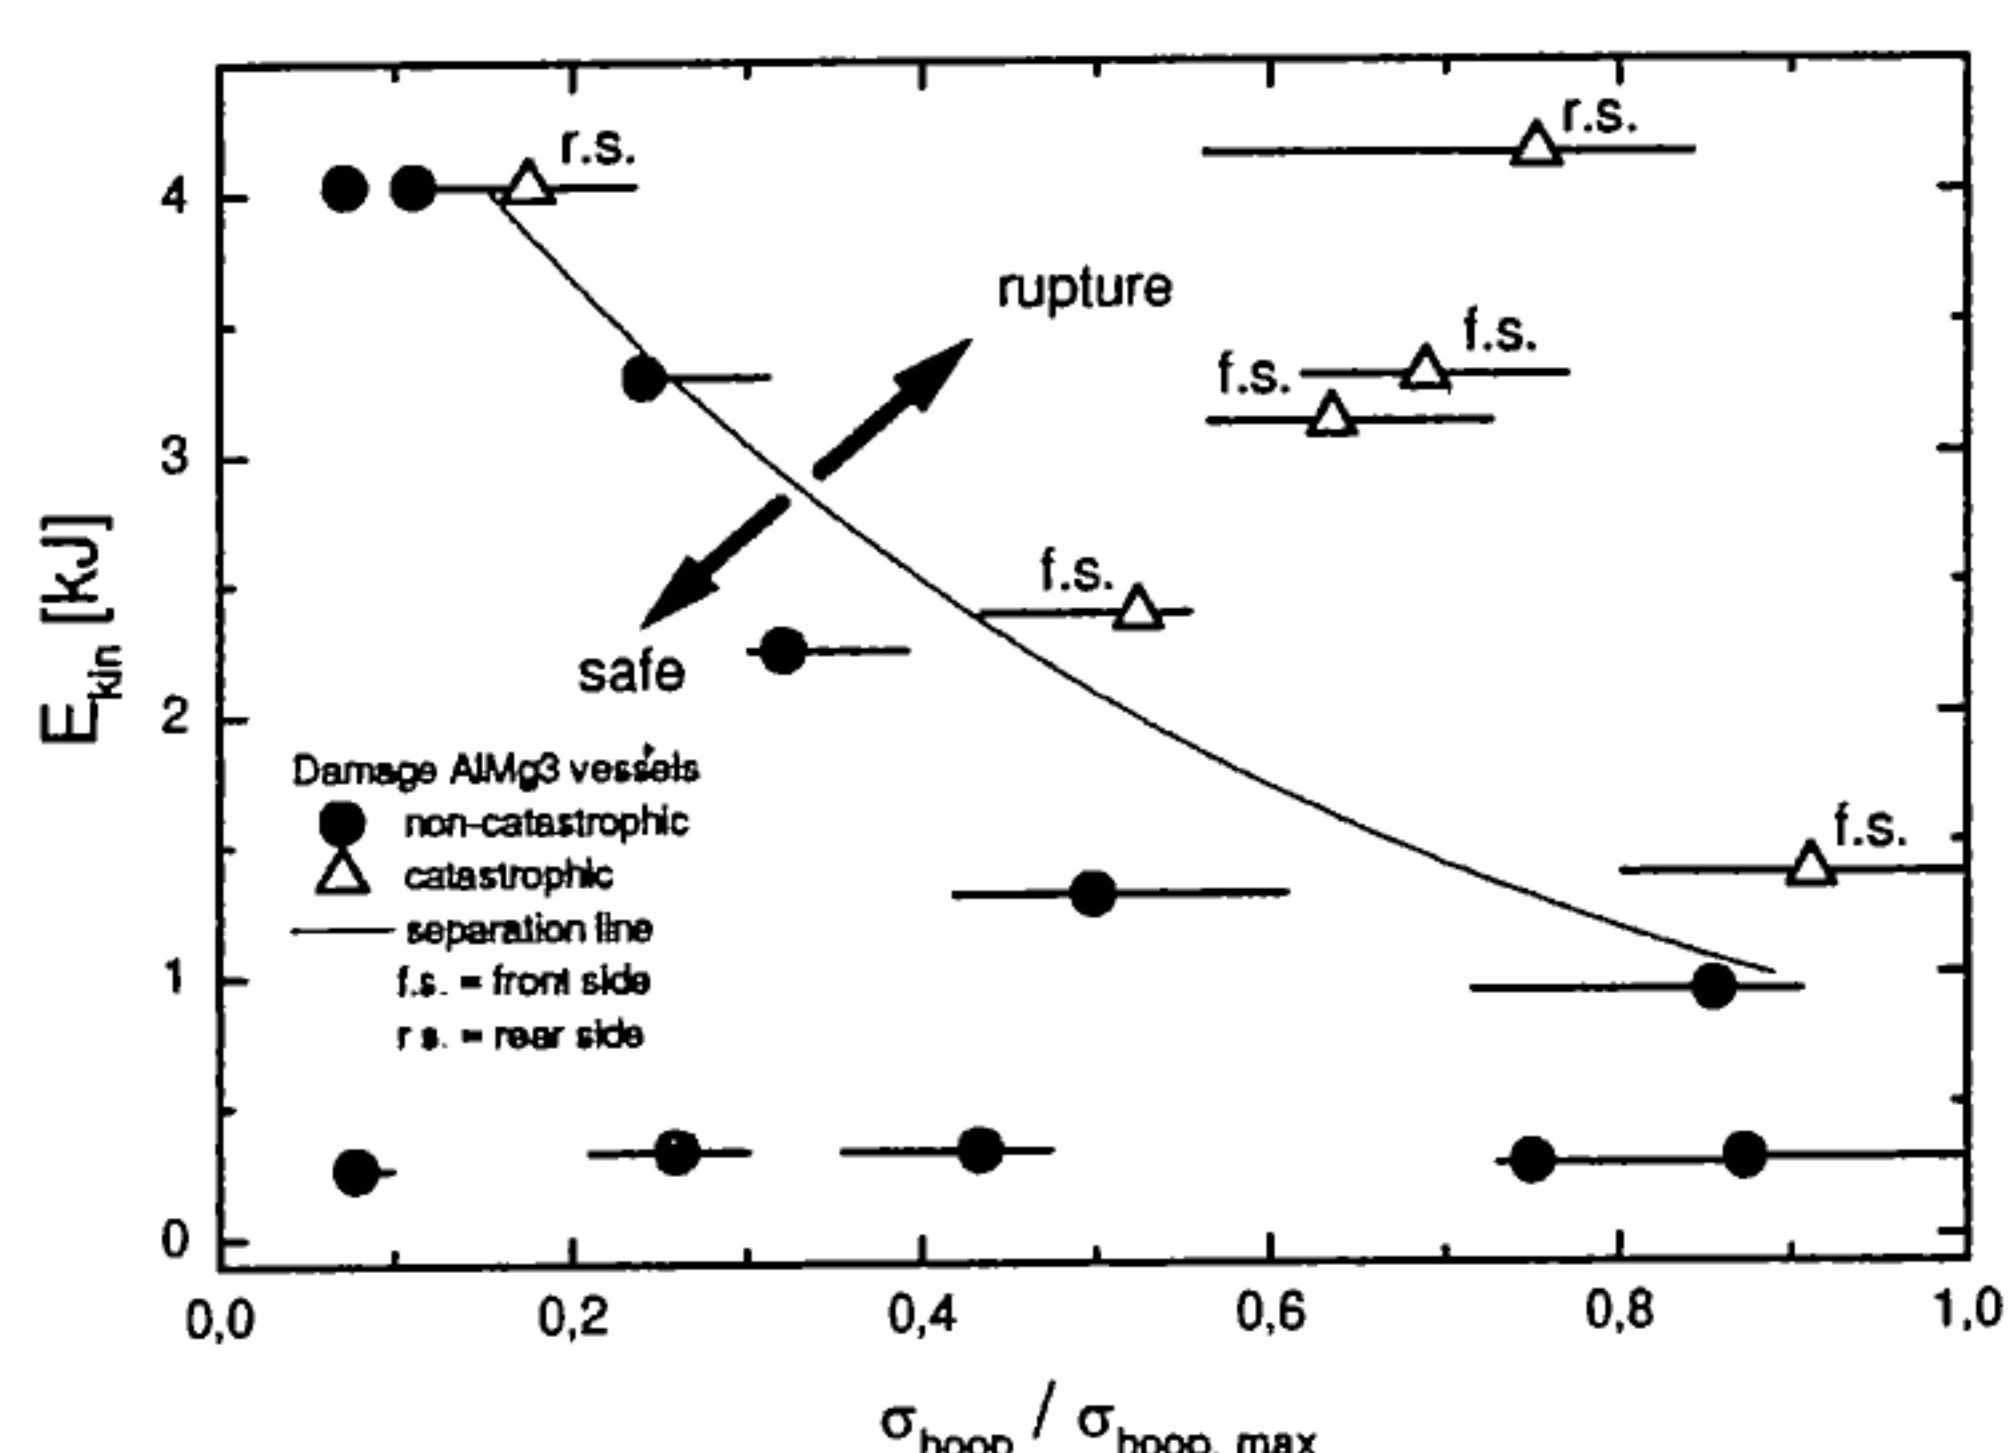
Figure 13 a. Experimental results from hypervelocity impact testing of aluminium pressure vessels

In Fig. 13 a/b and Fig. 14, all results are compiled in a diagram with the normalized wall stresses as abscissa and the projectile kinetic energy as ordinate. Error bars account for uncertainties in wall thickness and associated wall stresses in Fig. 3a. The experimental results are divided into 'catastrophic' and 'non-catastrophic'. The borderline that separates the

parameter regimes has been fit. Experimental parameters taken from below this line result in front wall perforation and different types of non-catastrophic rear side damage, whereas catastrophic rupture occurs for experimental parameters taken from above the curve. The validity of this line is restricted to the presented vessel geometries, materials, stress ranges, and impact velocities in the upper hypervelocity regime around 7 km/s. It is important to understand that this separation line has not been derived from physical laws.
