ORBITAL DEBRIS : A CASE STUDY OF AN IMPACT EVENT IN SOUTH AFRICA.

Mr Willem Botha

Satellite Applications Centre, ikomtek, CSIR, P O Box 395, Pretoria, South Africa.

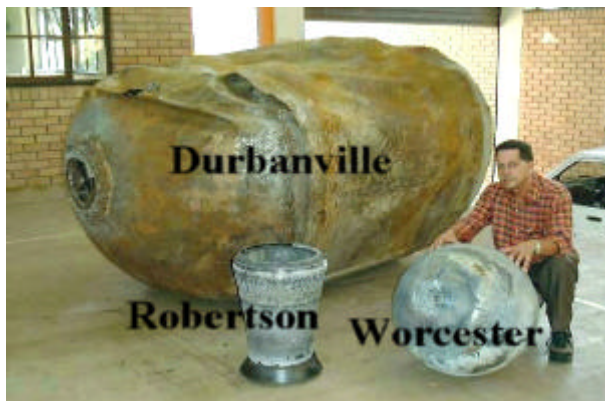
As can be seen from the map above, the largest steel tank-like object impacted near Durbanville, the metal sphere some 70 km further near Worcester and the composite material cone-like object another 23 km further near Roberson. These three pieces of space debris were photographed in the mechanical workshops of the South African Astronomical Observatory (SAAO), Observatory Cape Town and are shown in Fig. 2, [2] below.

Fig. 2. Three pieces of space debris that impacted in the western Cape photographed in mechanical workshops of SAAO, Cape Town.

This object is a cylindrical stainless steel tank some 2.7 metres long, 1.5 metres in diameter and weighing approximately 260 kilograms. This tank suffered significant damage and deformation during re-entry and subsequent impact with the ground. The tank has two hemispherical sections on either side of the cylinder one of which has a hole, some 30cm diameter. It is apparent that another object (probably the second stage liquid fuelled rocket motor) was securely attached to it with a large number of (29) bolts. See Fig. 2.

A metal sphere impacted the ground in the vineyards of the farm “Lemoenpoort” near Worcester at approximately 15:30 on Thursday 27 April 2000. This spherical metal object is some 60 centimetres in diameter and weighs approximately 33 kilogram. See Fig. 2.

The metal sphere was eventually secured by personnel of the SAAO, and transported to their mechanical workshops in Observatory, Cape Town (Fig. 2).

Eventually the pipe like object was collected by personnel from the SAAO and transported to their mechanical workshops in Observatory, Cape Town (Fig. 2).

Based on inspection of the space debris in the workshops of the SAAO, in Cape Town, (Fig. 2) the many media reports, imagery supplied by Dr Johnston and obtained from The Aerospace Corporation, Aerojet and SAAO web sites composite comparative images could be generated. Visual comparison of the “Western Cape” and “Texas” space debris, the latter identified as originating from a DELTA II second stage, show remarkable similarities. These comparisons leave little room for doubt as to the origin of the space debris that fell in the western Cape, as can be seen in Fig. 6, [6] Fig. 7 [7] and Fig. 8, [8] below.

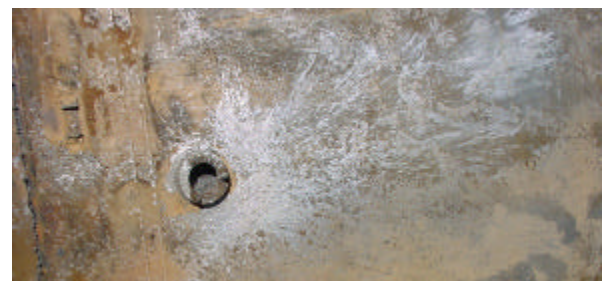
It is apparent that the some of the peripherals attached to the stainless steel tank, melted during re-entry as bright metal (probably aluminium) can be seen smeared against the stainless steel tank on several places. See Fig. 3, [3] below.

Fig. 3. Metal smears (probably aluminium) visible on stainless steel tank.

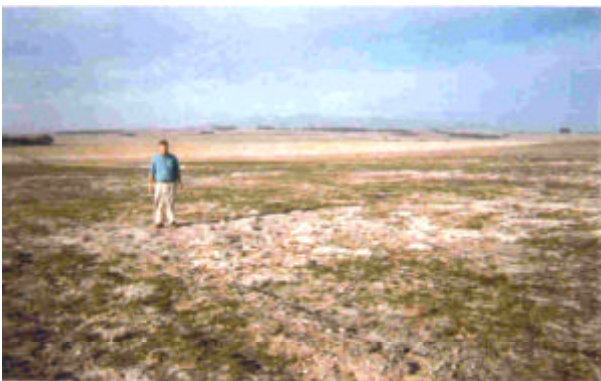
During a subsequent visit to the site on 17 May 2000, the point of impact could not be located in the short time available. It is believed that the stainless steel tank impacted the ground at a shallow angle, and probably bounced, rolled and tumbled for a considerable distance over the flat terrain, before finally coming to rest. The sparse grass in the area where the stainless steel tank was found, and for some distance to the west, was clearly subjected to a great deal of heat

As can be seen from Fig. 5, [5] below the area of impact is in a very sparsely populated area.

Fig.5. The man in the image is standing next to the spot where stainless steel propellant tank was recovered.

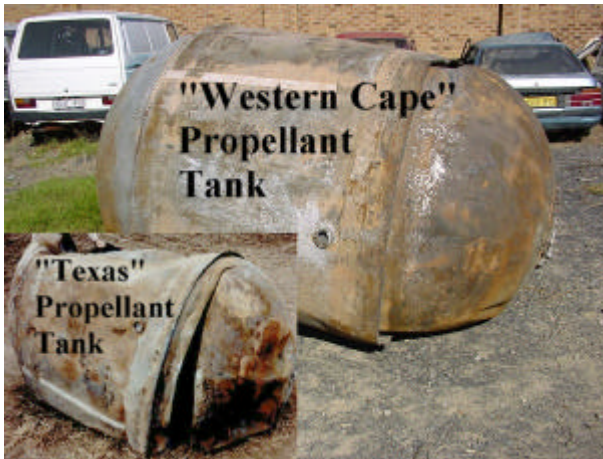
Fig. 6. Composite image of the propellant tank that impacted near Durbanville in the western Cape and the DELTA II second stage propellant tank that impacted in Texas on 22 January 1997. Similarities are obvious.

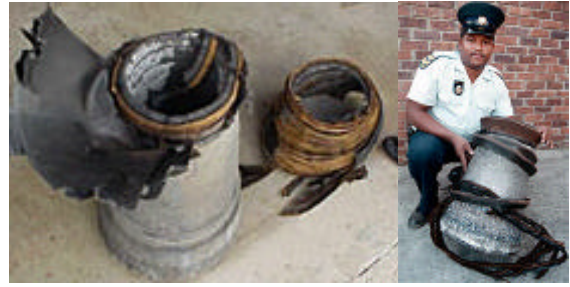
Fig. 8. Comparative image of the DELTA II second stage thrust chamber that impacted in Texas on the left, and thrust chamber that impacted near Robertson in the western Cape on the right. Similarities are obvious

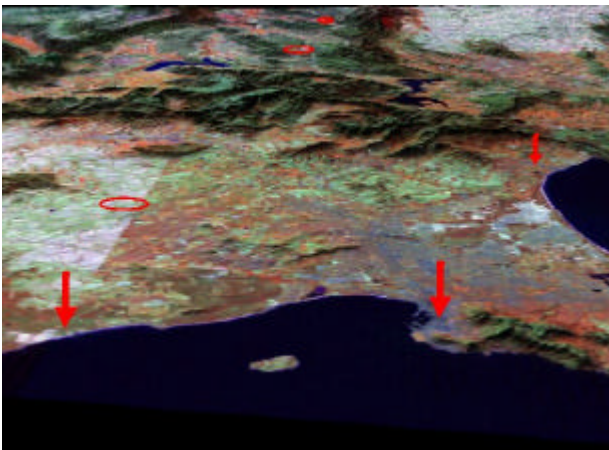
Fig. 10, shows a perspective view of the Cape Peninsula area. The red ellipses indicate the space debris impact sites. The red arrows (from left to right) the location of the Koeberg nuclear power station, Cape Town city and Sonchem, a manufacturer of commercial explosives and propellants for military applications.

If one looks at the perspective view of the Cape Peninsula in Fig. 10, [10] above generated by draping a LANDSAT 5 TM (Thematic Mapper) scene over a Digital Elevation Model (DEM) of the area, from a vantage point south of the re-entry trajectory of the space debris that impacted the area, a number of

interesting observations can be made. The impact areas are indicated by red ellipses decreasing in size to the east, south east.

The red arrows (from left to right) indicate the location of Koeberg, South Africa's only nuclear power station, down town Cape Town and the Cape Town harbour and the Sonchem installations near The Strand. Sonchem produces commercial explosives and a variety of propellants and explosives for military applications.

Koeberg and Cape Town are approximately 20 km from the propellant tank impact location, and the Sonchem installations some 40 km. It is not inconceivable that any of these locations may have been hit by the 250 kg white hot stainless steel propellant tank, or some of the other debris from the DELTA II second stage, with potentially disastrous consequences
