# ANALYSIS OF REENTERED DEBRIS AND IMPLICATIONS FOR SURVIVABILITY MODELING

William Ailor<sup>(1)</sup>, Wayne Hallman<sup>(2)</sup>, Gary Steckel<sup>(3)</sup>, Michael Weaver<sup>(4)</sup>

<sup>(1)</sup>The Aerospace Corporation, 2350 E. El Segundo Blvd, El Segundo, CA, USA; william.h.ailor@aero.org

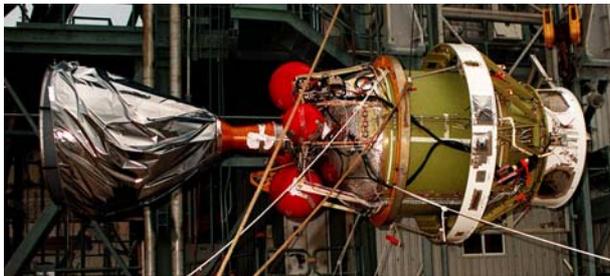
Figure 1. Delta II Second Stage (photo courtesy NASA).

Fig. 1 is representative of the pre-reentry configuration of the Delta II Stage 2 (Aerojet AJ10-118K) that was used to place an Air Force satellite into orbit on April 24, 1996. The stage reentered over Canada and the United States on January 22, 1997.

The propellant tank for the AJ10-118K (located forward of the spheres) has a cylindrical sidewall with hemispherical caps attached to each end. An interior hemisphere joins with the aft end-cap to form a spherical tank for nitrogen tetroxide oxidizer. The remainder of the internal volume above the oxidizer tank holds Aerozine-50 fuel. The entire propellant tank assembly is constructed of AISI 410 stainless steel. A fuel depletion burn is performed following spacecraft separation, so the tank is empty at reentry. Structural hardware is aluminum. Total dry weight of the stage is 920 kg.

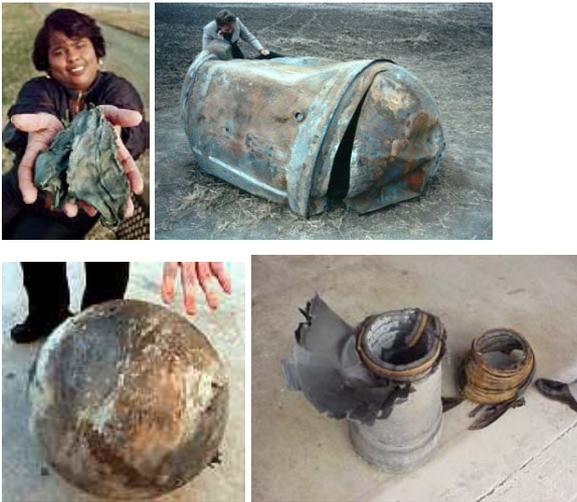
Fig. 2 shows the four debris items that were recovered after the reentry. Impact locations of each item are given in Table 4.

Figure 2. Debris from Delta II Second Stage reentry: clockwise from top left: Lightweight fragment, propellant tank, thrust chamber, sphere. Photos courtesy Tulsa World (staff photo by Brandi Stafford), NASA, Aerojet, NASA, respectively.

Metallurgical analyses were performed on the Delta II Stage II stainless steel propellant tank. Photographs (Fig. 2) show that the Stage II tank was largely intact upon landing on earth. The Stage II tank had a long circumferential crack and a flattened top resulting from impact damage (see Fig. 5).

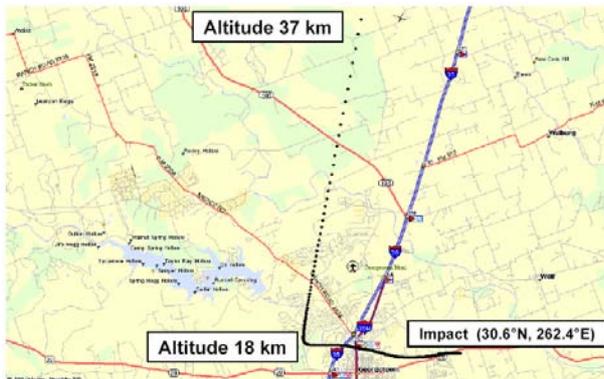
Fig. 3 shows the best estimate trajectory flown by the propellant tank. The wind moved each fragment off of the original ground track consistent with its ballistic coefficient. The small fragment was moved more than 33 km off-track, the large fuel tank 8 km, and the titanium sphere only 6 km.

Figure 3. Best-estimate trajectory for the propellant tank.

A breakup time of 9:36:7 GMT yielded the smallest errors in the tank and ball impact locations, so this was chosen as the most likely time for the Delta II Stage 2 breakup. The best-fit orbital elements at reentry and breakup are listed below in Table 5. Table 6 gives the derived ballistic coefficients for each object.

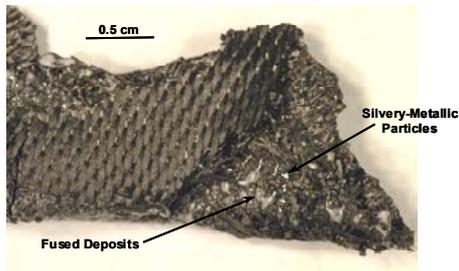
Visually, the sample provided appeared to be a piece of black colored woven fabric approximately 5 x 1.5 x 0.5 cm in size (Fig. 4). Initially, it was thought to be a piece of carbon or graphite fiber cloth because of its color. However, upon closer examination it was determined that the fibers were colorless, with a very dark coating. There were also colorless fused-looking deposits containing many bubbles and small ( $\cong$  1 mm) silvery-metallic particles. It was concluded that the metallic particles were resolidified aluminum with a very thin aluminum oxide surface layer.

Figure 4. Optical photograph of as-received debris from Turley, OK.

Representative pieces of the fiberglass/phenolic overwrap and glass roving were received from Aerojet, the manufacturer of the thrust chamber, for comparison with the debris piece. The chemical composition and weave pattern of the glass roving (E-glass) matched the debris. The black color of the debris probably resulted from rapid pyrolysis of the phenolic resin during reentry. The metallic deposits on the fabric are believed to be residue from the aluminum flange or “fingers,” which melted during reentry. E-glass has a “softening” point of around 850°C and a “melting” point of approximately 1200°C. The large number of bubbles trapped in the fused glass indicates the material was relatively fluid and had reached a temperature above the melting point of E-glass during reentry.

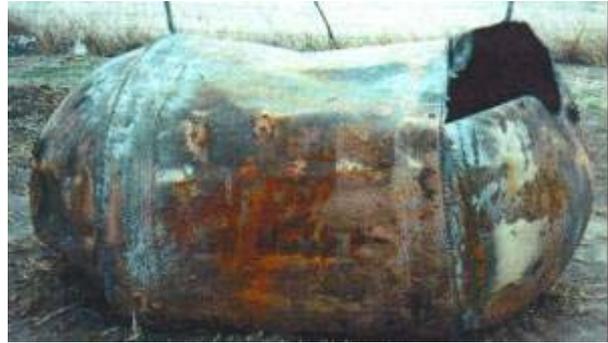
The melting point for the tank is approximately 1500°C for 410 stainless steel. The forward dome of the tank had a large hole with a jagged periphery of resolidified molten metal (Fig. 5), which had a black, burned appearance. Splashes of molten metal were seen at many locations on the exterior surface. These splashes were particularly heavy around the molten hole. Other observations included erosion/melting of stainless steel brackets, usually in regions where molten metal splashes were present. The tank had numerous small holes (2–3 mm) on the tank skin from micrometeoroid impacts. Most of the small holes were located on the aft end of the tank.

Figure 5. Photograph of reentered Delta II Stage II tank showing apparent molten hole (photo courtesy NASA).

EDXS analyses indicated that the molten metal splashes were aluminum. The tank had aluminum hardware attached to stainless steel brackets. It is theorized that the aluminum hardware melted from reentry heating and alloyed with the brackets causing the observed melting/erosion of some of the brackets. Some of the brackets, which have a melting point of around 1400°C, showed no evidence of melting. Therefore, it was concluded that the overall reentry temperature was >640°C (Al alloy melting point) and <1400°C.

Microstructural analyses were used to estimate overall reentry temperatures. Microstructural changes due to diffusion of aluminum splashes into the stainless steel tank in regions in which burning (discussed later) did not occur were used for the temperature analysis, and this showed that the peak overall reentry temperature on the tank was between 1200 and 1280°C.

Analysis of the two recovered tanks indicates a probable scenario for the localized melting observed on both<sup>11,13</sup>. It is hypothesized that the holes seen in both tanks were created by localized heating generated by burning of the heavy aluminum splashes during reentry. It is postulated that as the surface of the molten aluminum oxidized, the high shear force generated by the atmosphere during reentry immediately removed the oxide layer, allowing fresh aluminum to oxidize. Thus, a continuous oxidation process was established, which caused significant heating in addition to the frictional heat of reentry. Eventually, the high heating caused the aluminum to ignite. The burning aluminum could then produce heat intense enough to melt or ignite the stainless steel and Ti-6Al-4V tanks.<sup>14</sup> This scenario was supported by microstructural and EDXS analyses, which showed the presence of heavily oxidized, resolidified tank alloy at the periphery of the holes. It should be noted that this augmented heating from burning aluminum is generally not included in reentry breakup models.

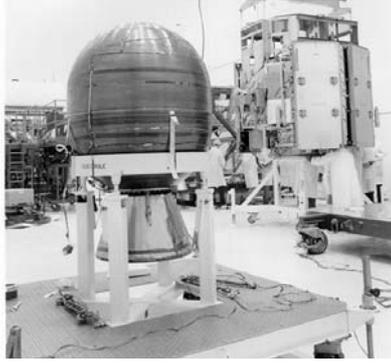
The third stage of a Delta II launch vehicle used to place a Global Positioning Satellite in orbit on May 13, 1993 reentered over Africa on January 12, 2001. Fig. 6 is representative of the pre-reentry configuration of the Star 48 motor, but does not include the aluminum structure required to attach to the payload or the second stage. Table 7 gives pre-reentry properties of the Star 48B rocket motor.

The Star-48B motor has two integral flanges, the lower for attachment to the third-stage spin table and the upper for attachment to the payload adapter (neither shown in the photo). The motor consists of a carbon-phenolic exit cone, Ti-6AL-4V titanium high-strength motor case, silica-filled rubber insulation system, and a solid propellant system using high-energy ammonium perchlorate and aluminum with binder.<sup>12</sup>

Figure 6. Star-48B rocket motor (photo courtesy U.S. Air Force)

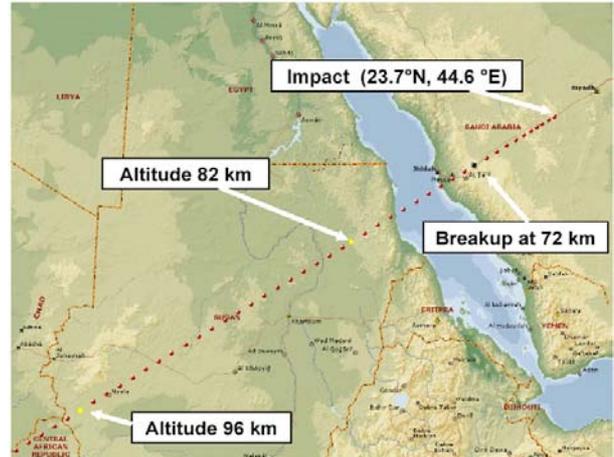
Table 8 gives an initial state vector for the Delta II Stage 3 prior to breakup. The trajectory reconstruction was performed using best available sensor data for the event. The results of the trajectory reconstruction show that the vehicle broke up at an altitude of 71.78 km over Saudi Arabia. The reconstructed ballistic coefficient prior to breakup was  $1.1505 \text{ kg/m}^2$ . The ballistic coefficient post breakup was  $2.2906 \text{ kg/m}^2$ . The predicted impact location for the stage was longitude =  $44.5961 \text{ deg E}$ , geodetic latitude =  $23.7201 \text{ deg}$ . A plot of the groundtrack during the final reentry is shown in Fig. 7.

Figure 7. Ground track for reentry of Delta II stage 3.

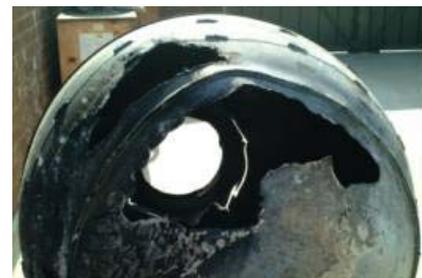
Fig. 8 shows the Delta 3<sup>rd</sup> Stage tank after reentry. Weight after impact was 67 kg, which included the weight of the nozzle remains. The tank had a small crack at the aft end, which was attributed to impact, but did not show significant deformation. It is believed that the composite exit cone made the initial impact with earth. The exit cone shattered, thereby absorbing most of the impact energy and minimizing damage to the titanium tank.

Reentry analyses predicted that the titanium tank would not reach its melting point ( $\cong 1650^\circ\text{C}$  for the Ti-6Al-4V alloy) during reentry. However, the forward dome of the tank had a large hole with a jagged boundary. No evidence of micrometeoroid impact damage was observed. A thorough analysis was performed on all observed features of the tank<sup>13</sup>, but only results of analyses relevant to reentry survivability modeling are summarized here.

Figure 8. Photograph of reentered Delta Third Stage tank showing molten holes.

Ti-6Al-4V is a two-phase alloy, and the peak reentry temperature can be estimated from the final microstructure. From the proportions and morphology of the phases, the peak reentry temperature for the

titanium tank was estimated to be between 1050 and 1200°C.
