THE INTERNATIONAL SPACE STATION AND THE SPACE DEBRIS ENVIRONMENT: 10 YEARS ON

Nicholas Johnson

*Orbital Debris Program Office, NASA Johnson Space Center, NASA, 2101 NASA Parkway, Houston, TX 77058, USA,
Nicholas.L.Johnson@nasa.gov*

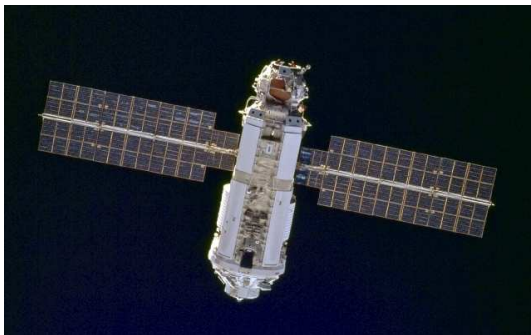
Figure 1. The first element of ISS, Zarya (left, taken by STS-88) was launched in November, 1998. By November 2008, ISS had evolved into a complex, multinational, highly capable outpost (right, taken by STS-126).

The first element of the International Space Station (ISS) was launched on 20 November, 1998, in the form of the 20-metric-ton Zarya module. During the subsequent ten years, 77 additional missions had been flown by the United States, the Russian Federation, and the European Space Agency for construction or logistical purposes. From a single unit to the largest and most complex vehicle ever assembled in space, the ISS now spans almost 100 meters across its main truss and has a mass of nearly 300 metric tons (Fig. 1)

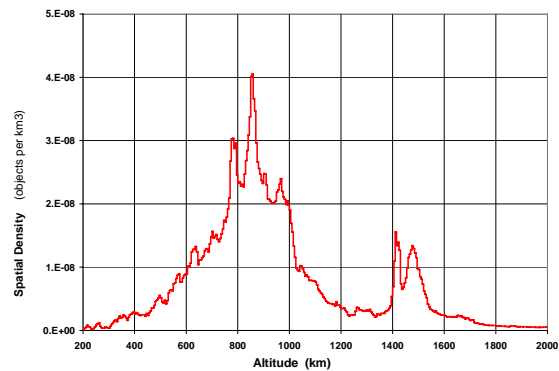
Figure 2. Average spatial density of cataloged objects in low Earth orbit at the end of 2008

Typically, the ISS orbits the Earth at an altitude of about 350 km, but the mean altitude has varied from about 330 km to 400 km, depending upon atmospheric density (influenced by the solar activity cycle) and operational constraints. Consequently, the ISS enjoys a relatively benign orbital debris environment in comparison with most robotic spacecraft operating in low Earth orbit (Fig. 2). However, the much larger size of the ISS means that annual collision rates with orbital debris are significant.

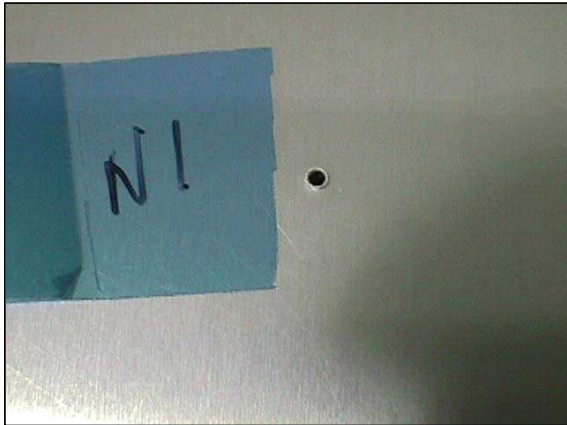
Figure 11. Hole found in the space debris shield after the first flight of the MPLM to the ISS in 2001

The first five missions involving an MPLM resulted in an exposure time of more than 700 hours and two instances of penetration through the outer aluminum bumper [5-6]. On the maiden flight of the MPLM, a paint particle with an estimated diameter of ~0.5 mm left a 1.4 mm diameter hole in one of the bumper segments (Fig. 11). After the fourth flight of an MPLM, a 1.2-mm diameter hole was discovered in the space debris shield, the victim of an impact by a stainless steel particle with a diameter assessed to be 0.2 mm. By the end of 2008, a total of eight MPLM missions had been conducted, and nearly 200 instances of orbital debris or micrometeoroid impacts had been identified.

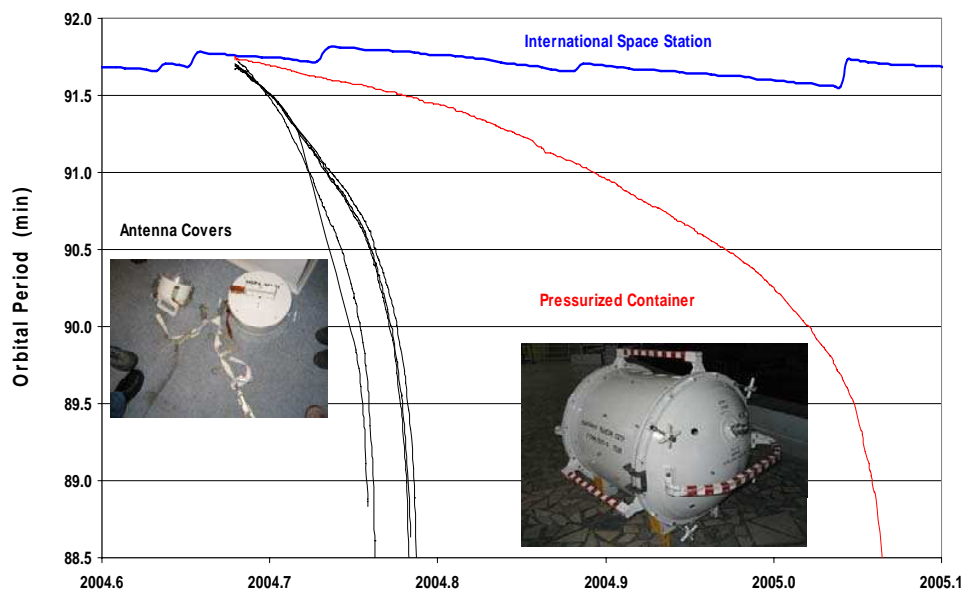
Figure 12. Orbital decay histories of sample debris from the ISS

During its decade of operations the ISS itself has become a source of orbital debris, both large and small. Most large debris were released during EVA activities, many accidentally. By the 10th anniversary of the ISS, the U.S. SSN had detected and cataloged 65 debris from the outpost, not including operational spacecraft releases like the TNS-0 small sat in March 2005. Inadvertent losses ranged from a camera to a variety of tools to a complete tool bag to a foot restraint. Intentional debris releases included towels, equipment covers and carriers, hardware too large or too dangerous to return to Earth in a logistics vehicle, and an old space suit. On average, these objects fell harmlessly back to Earth in less than two months (Figs. 12 and 13). The cumulative number of debris object-years is almost

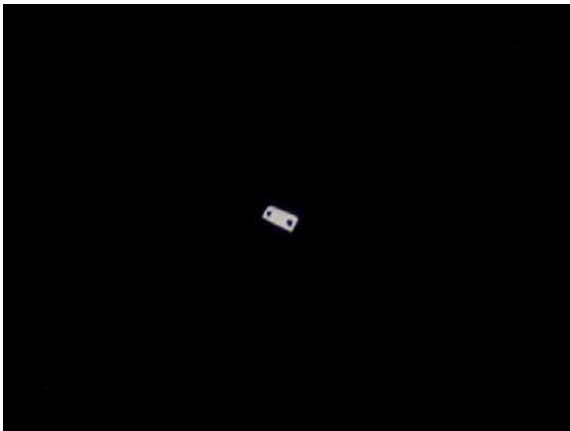
Figure 14. Small debris observed from ISS in June 2003

An unknown number of debris too small to be tracked and cataloged has also been generated. Very small secondary orbital debris are likely produced when the ISS is struck by high speed particles. Occasionally, the ISS crew has reported seeing and in some cases photographing objects several centimeters in size as they drift away from the station (Fig. 14). Due to their low altitude and likely high area-to-mass ratios, these objects are believed to be even shorter-lived than their cataloged counterparts.
