## ASSESSMENT OF HIGH VELOCITY IMPACTS ON EXPOSED SPACE SHUTTLE SURFACES

Eric L. Christiansen,\* Ronald P. Bernhard,\*\* James L. Hyde,\*\*  
Justin H. Kerr,\* Karen S. Edelstein,\*  
Javier Ortega,\*\* and Jeanne Lee Crews\*

\*NASA Lyndon B. Johnson Space Center  
\*\*Lockheed Engineering and Sciences Company  
Houston, TX 77058

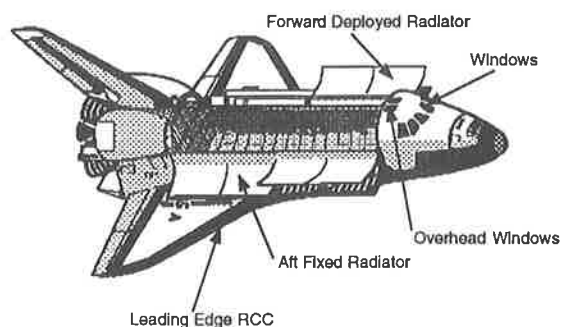
Figure 1. Orbiter Radiators, Windows, and Reinforced Carbon-Carbon (RCC)

The Orbiter's crew module windows shown in Figure 1 include pairs in the forward, middle, side, and overhead positions. The total exposed area of these 8 windows is 3.32 m<sup>2</sup>. Each of these windows are sets of three glass panes, an outer thermal pane followed by redundant pressure panes. The thermal panes are made of fused silica glass (Corning 7940). Details of the Space Shuttle Orbiter window system, operational and maintenance requirements are described elsewhere (Ref. 9).

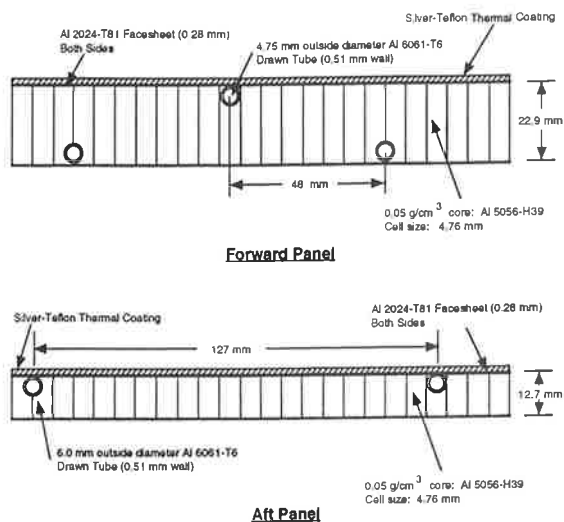
Figure 2. Orbiter Radiator Cross-Section

The Orbiter radiators consist of 8 panels divided into starboard and port, forward (No. 1 and 2) and aft panels (No. 3 and 4). Each radiator panel is a 4.6 m x 3.2 m curved aluminum honeycomb structure from 1.3 cm (aft) to 2.3 cm thick (forward) with 0.028 cm thick aluminum (2024-T81) facesheets (Figure 2). A silver-Teflon thermal control tape is bonded to the exterior, exposed side of the radiator panels (Figure 3). Freon is pumped through aluminum tubes that are mounted under the facesheets within the honeycomb at periodic intervals. The forward radiator panels are deployable (35.5° at the hinge line) but were not deployed during the STS-50 mission.

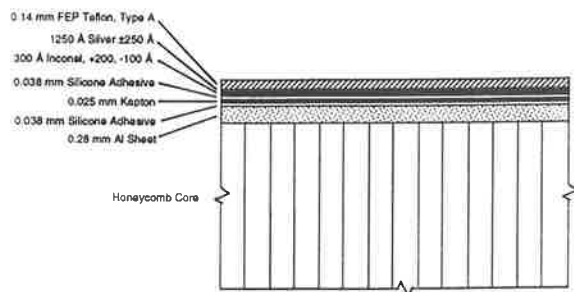
Figure 3. Silver-Teflon Radiator Coating

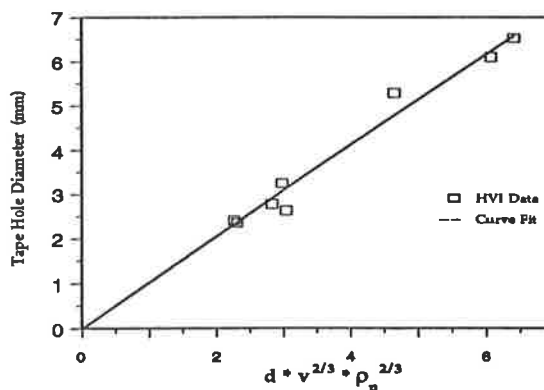
Figure 6. HVI Test Data and Radiator Tape Hole Size Correlation

Based on the HVI test results using aluminum and Nylon projectiles (Figure 6), a correlation was developed for hole diameter,  $D_{hole}$  (mm), in the tape:
