A HISTORY OF METEOROID AND ORBITAL DEBRIS IMPACTS ON THE SPACE SHUTTLE

J.L. Hyde⁽¹⁾, E.L. Christiansen⁽²⁾, R.P. Bernhard⁽³⁾, J.H. Kerr⁽⁴⁾, D.M. Lear⁽³⁾

ABSTRACT

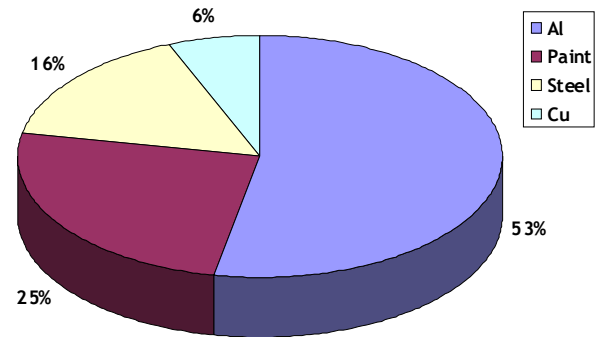
STS-50 through STS-97. Of the 76 impact replacements, SEM/EDXA revealed 32 were from orbital debris, 17 from meteoroids and 27 were unknown (no definitive SEM/EDXA results) or had no sample returned. Fig.3 illustrates the composition of orbital debris for the 32 debris impacts that caused a window replacement. Aluminum containing debris results in about half of the window replacements due to orbital debris impacts (which are ~1/2 of the total replacements). Paint, steel, titanium and copper cause the other large impacts.

Fig. 3. Composition of orbital debris particles that caused 32 window replacements during the period from STS-50 (June 1992) through STS-97 (November 2000)

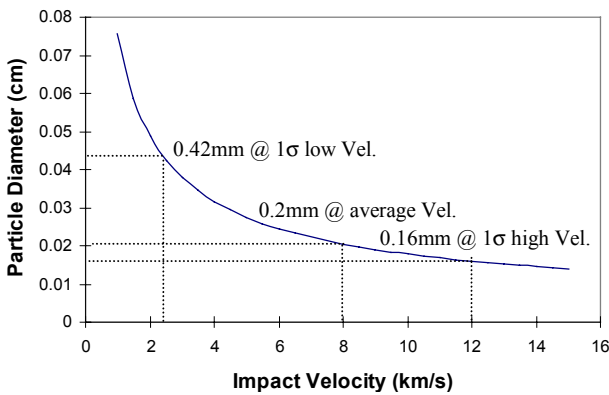
A sensitivity analysis on estimated projectile size has been accomplished [3]. The sensitivity analysis indicates that the range of potential projectile sizes for a particular impact (within a 1-sigma velocity range centered on the mean) is influenced more by the low velocity component than the high end of the velocity range (Fig. 7). This analysis indicates average estimated particle size causing orbital debris damage given in Table 1 is biased toward the lower end of the potential size range.

Fig. 7. Particle size sensitivity analysis considering 1-sigma variation in possible debris impact velocities for the STS-50 window #4 impact

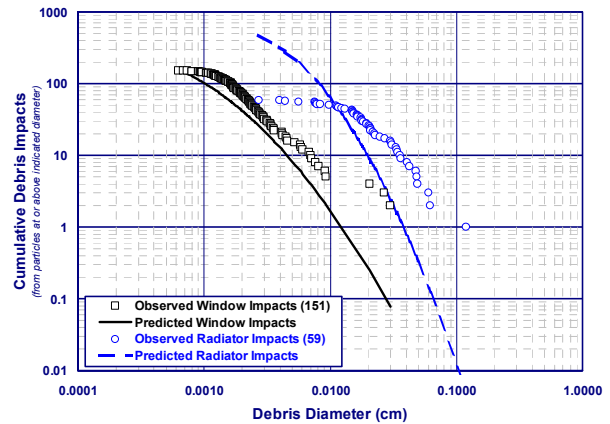
shown, actual radiator and window damage exceeds predicted using ORDEM96 by factors of 2 or more.

It should be noted that all “Unknowns” in the window impact database have been classified as “meteoroids”, so that the on-orbit debris impact total shown in Fig.8 potentially undercounts debris impacts to the windows. More details on these assessments can be found elsewhere [6, 18-19].

Fig. 8. Comparison of window and radiator damage (actual in circles/squares) to predicted (lines) Cumulative for 21 Flights: STS-50, 56, 71, 72, 73, 75, 76, 77, 79, 80, 81, 84, 85, 86, 87, 88, 89, 91, 94, 95, 96
