MITIGATION OF EMU CUT GLOVE HAZARD FROM MICROMETEOROID AND ORBITAL DEBRIS IMPACTS ON ISS HANDRAILS

ABSTRACT

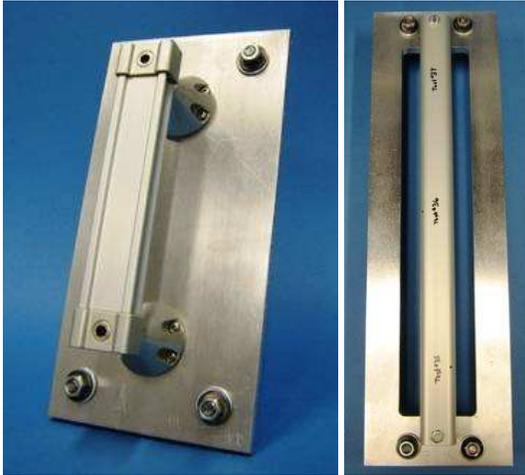
Two handrail configurations were selected for characterization of MMOD impact damage features on ISS handrails: a rectangular handrail with channelled edges (NASA part no. SDD33107728-073), and a tubular handrail (part number SDD39122635-001), both of which are shown in Figure 3.

Figure 3: ISS handrail target configuration. Left: rectangular handrail; Right: tube handrail

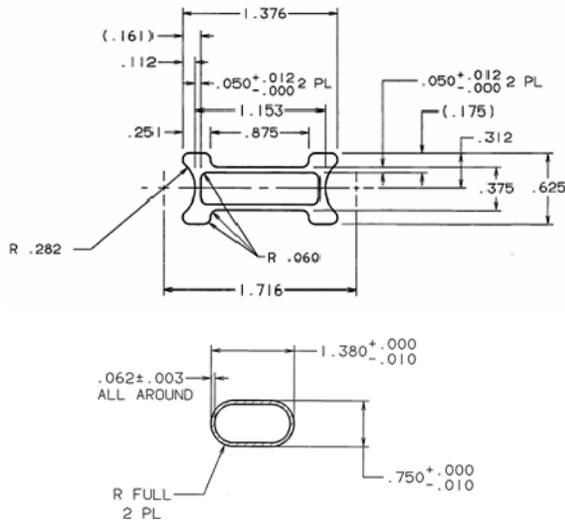
The rectangular handrail configuration has a nominal thickness of 1.27 mm (0.05") which is reinforced to 4.445 mm (0.175") at the corners. The tubular handrail has a nominal thickness of 1.57 mm (0.62"). Dimensions of the handrails are provided in Figure 4. Both handrails are manufactured from Al 6061-T6.

Figure 4: Cross-sectional diagram of rectangular (upper) and tubular (lower) ISS handrails subject to testing (dimensions in inches)
