Surveys of Returned ISS Hardware for MMOD Impacts

Hyde, J.L.⁽¹⁾, Christiansen, E.L.⁽²⁾, Lear, D.M.⁽³⁾, Nagy, K.⁽⁴⁾, Berger, E.L.⁽⁵⁾

1 PMA-2 COVER

5 AIRLOCK SHIELD PANELS

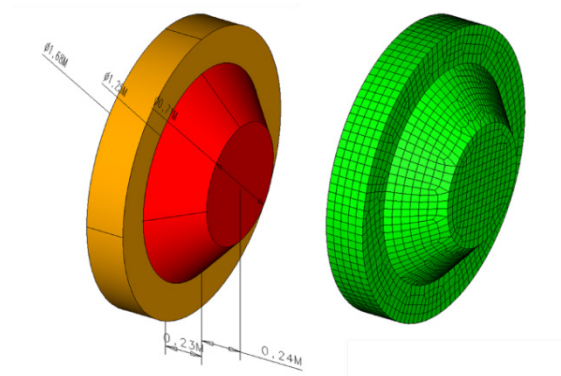
Figure 8. PMA-2 cover surface geometry and FE model

The analysis procedure in Bumper 3 [6] involved calculating the expected number of MM and OD impacts from selected particle diameters in Tab. 1. The standalone finite element representation of the PMA-2 cover used as the input geometry in Bumper 3 is shown in the right hand side of Fig. 8.

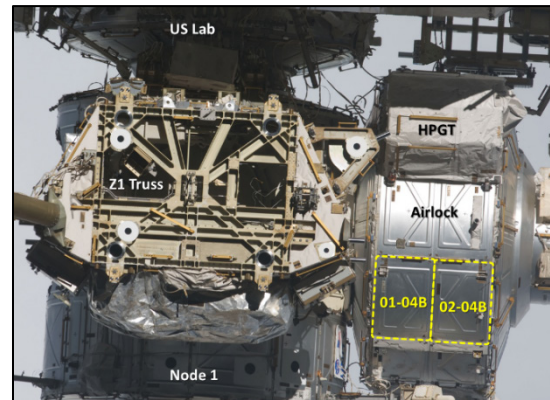
Figure 10. Location of removed airlock shields

years of exposure time. The post flight MMOD inspection was performed by NASA and Jacobs personnel on January 7, 2011 in JSC Building 13. Fig. 10 shows the zenith side of the airlock with the removed shield panels highlighted.

The airlock shield panels are made of aluminum 6061-T6 and are each 1.3 m long, 0.84 m wide and 0.2 cm thick. The survey of these panels was limited to a visual inspection with additional characterization by handheld digital microscope. Craters less than 0.25 mm diameter were not recorded. The inspection measured the “inside diameter” of the crater, recorded at the original height of the panel surface. A total of 58 craters were observed, 34 on the outboard panel and 24 on the inboard. The inspected shield panels can be seen in Fig. 11 with the 58 regions of interest flagged (colored arrows). 56 of the 58 observed craters were nearly circular, with only two elliptical craters recorded. The largest circular impact crater (Fig. 12) measured 1.8 mm in diameter.

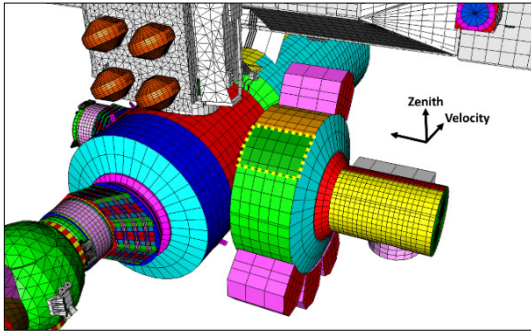
Figure 18. Airlock shield FEM

The analysis was performed against a 1.98 m² finite element mesh area on the equipment lock region of the airlock. The region is highlighted in Fig. 18.
