# EJECTA PRODUCTION MECHANISMS ON PAINTED SURFACES

## ABSTRACT

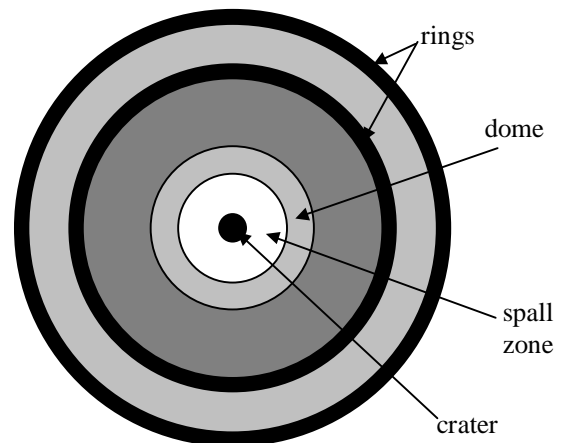
Fig. 2 : Plan view of a « typical » impact into a painted surface

When the projectile energy is higher, a crater is formed into the substrate and large paint fragments, called spalls, are ejected. The size of the spall zone, which is the zone where the paint is removed from the aluminium surface surrounding the crater, varies from approximately 2 to 5 crater diameters.

In some cases, a shock zone appears, forming rings with a diameter up to 20 times the crater diameter [4].

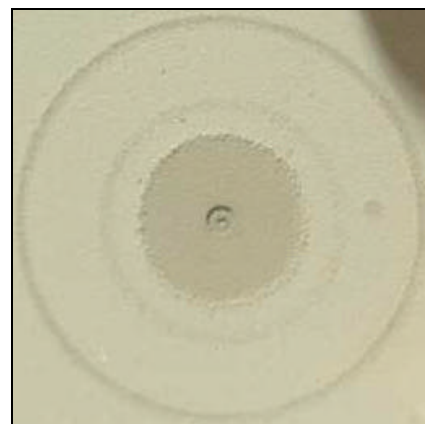
Fig. 3 : Impact on a painted surface
