# HYPER VELOCITY IMPACT STUDIES SIMULATING DEBRIS COLLISION ON COMPOSITES MATERIAL

## ABSTRACT

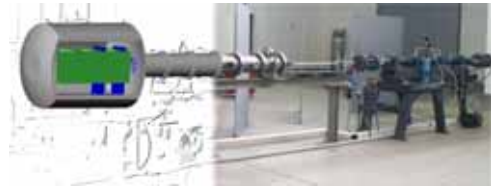
Fig.2 Two stage light gas gun  
( Pictured by CISAS)

The experiments were conducted by shooting on each type of target with aluminium sphere projectiles of 0.8mm, 1.5 mm and 2.5mm diameter, at 0° impact angle, around speed 2-4-5 km/s (including 10% error), at room temperature, in the 70mbr vacuum chamber. The total number of tests was 27 shots. These collision experiments were conducted at the Hypervelocity Impact Facility in 'Centre of Studies and Activities for Space CISAS "G. Colombo" - University of Padova', by using the two-stage light-gas gun (shown in Fig.2).

The test specification is shown in Table.2. This two stage light-gas gun has an capability of shooting out the projectile 2~5.5km/s in speed, 0.4~3mm in projectile diameter and 100mg in mass using sabot. Fig.3 shows the fixation of CFRP target plate in the vacuum chamber of light-gas gun facility.

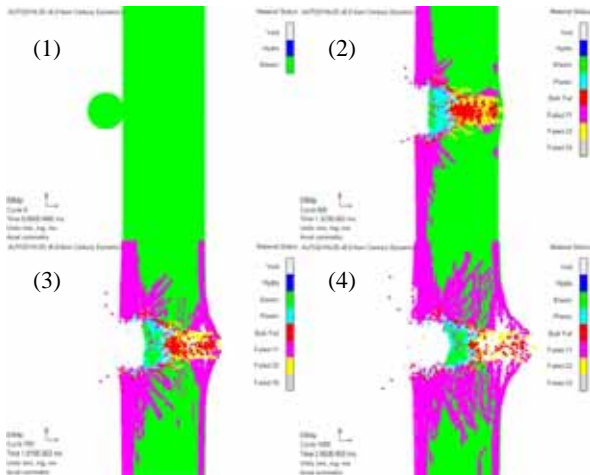
Fig.15 AUTODYN simulation results

In order to investigate the fibers are exfoliated greatly near the plate surface, the simulation was performed using AUTODYN. The model of projectile and plate were prepared for the SPH analysis. Fig.15 shows a result of numerical simulation to a time series from (1) to (4). Near the surface by the side of a collision, figure (2) shows that tensile strain of out plane direction has reached the fracture limit. This means that delamination has progressed near front side and Mode I fracture occurred near *back* side. By figure (3) and (4), it can be understood that delamination occurred and progressed near *back* side. These analysis results are effective in explanation of the phenomenon that actually occurred.

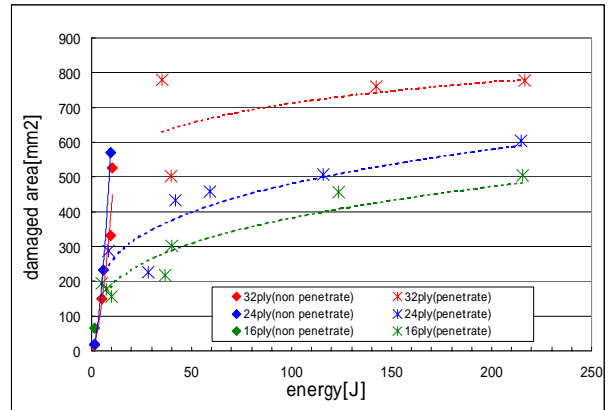
Fig.12 Relation between damaged area and Impact energy

Fig.12 shows the relation between the damage area and impact energy by processing the images according to the definition of damaged area in Fig.9. A horizontal axis is the impact energy, and a vertical axis is the measured damage area.

It is understood that the characteristic is different between the case of non-penetration and the case of penetration. There are little relations to the plate thickness in non-penetration case, and most of values gather on one line. However, in penetration case, the damaged area became larger when the target plate thickness became thicker, even though impact energy was same for each plate thickness. It can be understood that thicker plate could absorb more energy than thin plate even though the same impact energy was given.

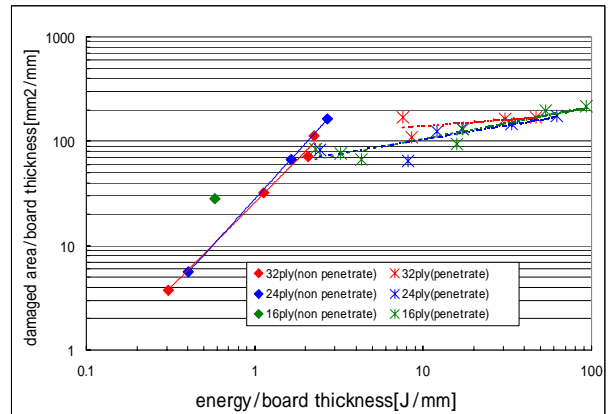
Fig.13 Relation between damaged area / plate thickness and impact energy / plate thickness (log-log)

Fig.13 is the chart that normalized the both axis by the plate thickness. There is some possibility of including the observing and definition error by observer, so the result was arranged by both logarithms in Fig.13. As a consequence, the values are divided into almost on two lines of non-penetration and penetration.

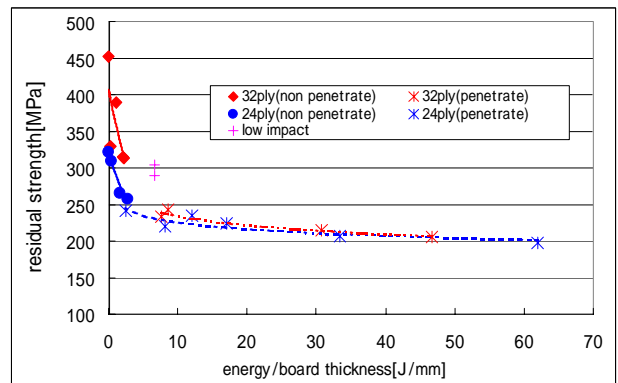
Fig.14 Relation between residual strength and impact energy / plate thickness

The destruction mode on 16ply targets were different from 24ply and 32ply plate when a compression test was performed, because the plate thickness of 16ply was very thin and a buckling was occurred before coming up to compression strength. Therefore, we discussed only with the residual stress of 24ply and 32ply plate in Fig.14.

Impact energy is normalized by plate thickness as same way as usual CAI test. In non-penetration case, different thickness plate has different residual strength. However, in penetration case, different thickness plate has same residual strength and they are on one line. It has been understood that there is a linear relation between the impact energy and residual strength in penetration case.
