# HYPERVELOCITY IMPACT TESTING OF CFRP/AL HONEYCOMB SATELLITE STRUCTURES

In this paper, ballistic limit tests on 5 different Carbon-fibre Reinforced (CFRP) Honeycomb (H/C) sandwich panels (SP) are reported. The CFRP H/C SPs presented are typical for application in various current satellite structures. Conductivity measurements of the downrange fragment cloud have been made using electrodes that were mounted on the witness plate. It was found that the fragment cloud acts as a conductive medium between the electrodes, enabling current flows across the electrodes of several tens of milli-amperes with duration of a few milliseconds. Initial impact tests on harnesses behind CFRP H/C SP have been performed. The harnesses consisted of two circuits that were operated at different voltages (28 V and 50V). Besides severe impact damage to the cables, leakage currents between the circuits have been observed. Additionally, large peak voltages in the electrical circuits during hypervelocity impact have been measured.

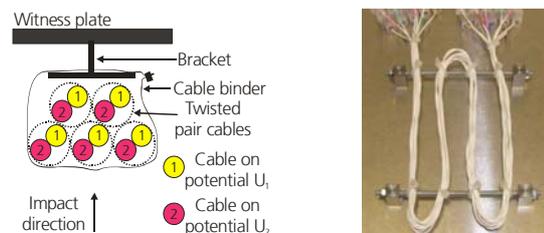
Figure 3. Cable set-up and fixation to witness plate

For the harness impact tests the same witness plate was selected as for the electrode impact tests. The cables (type: Raychem 55A0124-20-9/9) were operated during impact, having a consumer (resistor) fixed to them at the one end. The cables were at two different positive potentials operating against a common ground potential: one half at +28 V, the other at +50 V. The resistors were selected such that currents of ca. 2.5 A flow through each of the two circuits. All 5 cables on one potential were operated in parallel to facilitate the failure analysis after the tests. Each cable from the lower potential was twisted with a cable from the higher potential. The harness was manufactured by combining the 5 twisted pairs to one strand and fixing it with a cable binder to a bracket that was spaced 10 mm in front of the witness plate (Fig. 3). The harness strands are spaced 20 mm and wound 4 times to have better coverage of the fragment dispersion area.

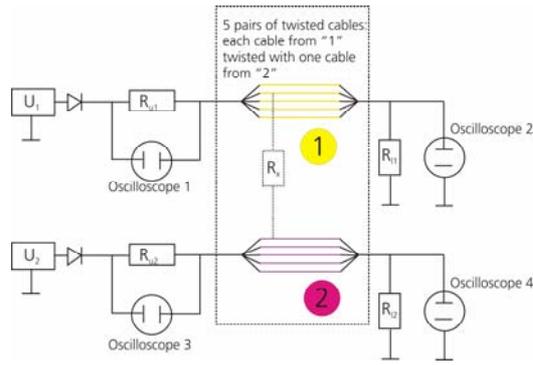
Figure 4. Electrical set-up for harness impact tests

The electrical set-up is shown in Fig. 4. Two power sources provide electrical power to the load resistors  $R_l$ . The section between the measurement resistors  $R_u$  and the load resistors  $R_l$  (i.e. the harness bundles) corresponds to the area where the impact occurs. The resistor  $R_x$  represents the resistance between the two conductors during and after impact when leakage currents and short currents are expected to flow across the junction. This set-up allows measurement of the resistance, voltages, and currents between the two cables and common ground.

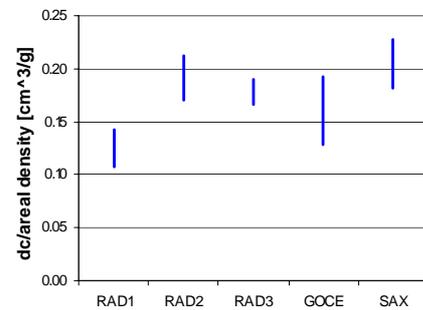
Figure 5. Normalized Ballistic Protection Capability of the tested CFRP H/C SP ( $0^\circ$  impact,  $3 < v < 7$  km/s)

For both criteria the threshold conditions are of interest and can be found for a selection of the configurations in Tab. 1. The projectile diameters which result in detached spall from the rear face-sheet of the CFRP H/C SP or any larger damage to the rear face-sheet are defined as the critical projectile diameters ( $d_c$ ). The  $d_c$  for all structures has been summarized in Tab. 2 over a range of impact angles and velocity regimes. In order to allow a quantitative comparison between the protection performances offered by the different CFRP H/C SPs tested in this campaign, the “normalized ballistic protection capability” (NBPC) was defined. This capability is the ratio of critical projectile diameter divided by the areal weight of the sample and is plotted in Fig. 5 for five different configurations impacted normally ( $0^\circ$ ) by projectiles with velocities exceeding 3

km/s. The plotted NBPC covers a range of values for each configuration. The NBPC is presented as a range given that the limited amount of impact tests performed during the test campaign does not allow exact determination of the failure criterion thresholds. However, it is fairly obvious that 4 out of 5 configurations have relatively the same normalized protection capability. The RAD1 configuration has a clearly lower protective capability. The main difference of the RAD1 structure to the other structures investigated is the thick honeycomb core (50.8 mm). Analysis is ongoing.

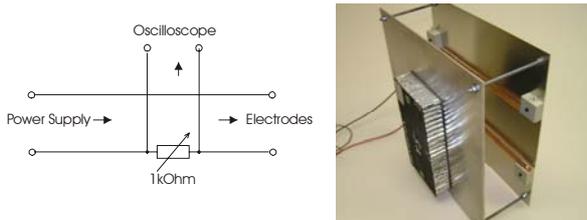
Figure 6. Complete target showing SAX CFRP H/C SP mounted on a frame and witness plate instrumented with electrodes

The set-up for cloud conductivity measurements allows the simultaneous investigation of mechanical impact damage to interior equipment and the electrical effects related to satellite interior contamination by conductive fibers. On the whole, about ten impact tests related to cloud conductivity measurements have been made so far of which one representative test result is analyzed in more detail here. The analysis concerns EMI Exp. S-4622 on a set-up involving a BEPPO-SAX CFRP H/C SP sample (Fig. 6). The impact conditions were 4.0mm/86.67 mg Al sphere,  $v = 6.64 \text{ km/s}$ ,  $\alpha = 45^\circ$ .

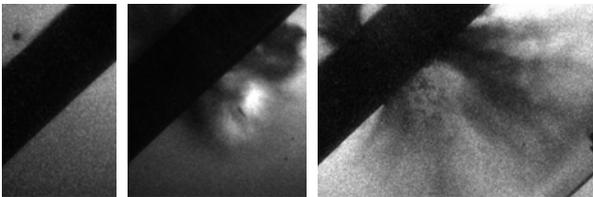
Figure 7. Optical Shadowgraphs of impact tests on SAX CFRP H/C SP with witness plate at a stand-off of 100 mm, EMI Exp. S-4622. Trigger times: 0, 20, 80  $\mu\text{s}$  wrt to first picture (4 mm Al-sphere,  $v = 6.64 \text{ km/s}$ ,  $\alpha = 45^\circ$ )

In Fig. 7, digital high-speed shadowgraph records of impact on the CFRP H/C SP, propagation of the fragment cloud, and impact of the cloud on the witness plate, is shown. As can be seen, there is considerable amounts of conductive fiber ejecta about the witness plate and therefore the electrodes.

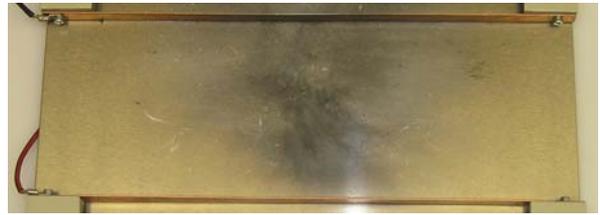
Figure 8. Impact damage in 1.5 mm thick witness plate after EMI Exp. 4622

The actual impact damage in the witness plate is minor (Fig. 8): there are no impact craters observable, and the plate is covered extensively by Al-deposits over an area of approx. 150 mm x 110 mm, beginning about 50 mm above the witness plate center and some black dust stemming from CFRP fibers. The plate is not deformed, there is no noticeable bulging. Clearly the impulsive load transmitted to the plate is minor. However, the electrical signals obtained reveal intense electrical conduction between the electrodes during and after the cloud passage through the electrodes (Fig. 9).

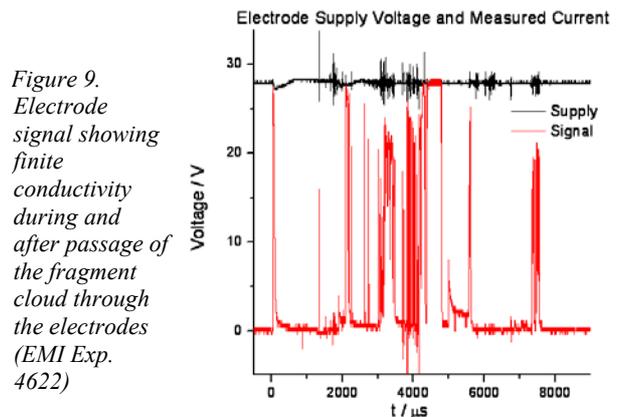
Figure 9. Electrode signal showing finite conductivity during and after passage of the fragment cloud through the electrodes (EMI Exp. 4622)

Considering the electrical load resistor of 1 k $\Omega$  that is connected in parallel to the oscilloscope, currents of

several tens of milli-amperes flowing between the electrodes have been measured in this experiment, pulsating for a total duration of approximately 8 milliseconds after the impact. Based on the currents flowing between the electrodes and the applied voltage, the resistance between the electrodes was calculated to temporarily amount to below 50  $\Omega$ .

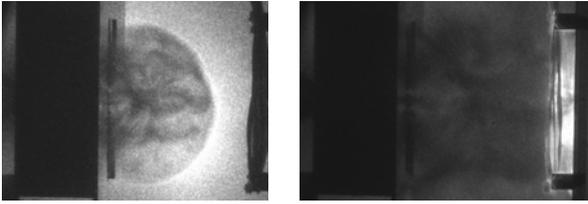
Figure 11. Optical Shadowgraphs of impact tests on RAD1 CFRP H/C SP with harness placed at a stand-off of 100 mm (+ witness plate behind), EMI Exp. S-4633. Trigger times: 10 and 20  $\mu\text{s}$  after impact ( $d=5\text{ mm}$ ,  $v=6.81\text{ km/s}$ ,  $\alpha=0^\circ$ )

The digital high-speed shadowgraphs are displayed in Fig. 11. In Fig. 12 the mechanical damage of the cables is shown (3 cables were severed; 11 additional cables had the insulation removed/destroyed).

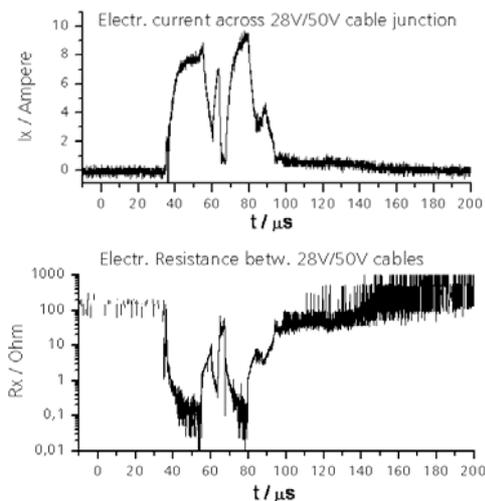
Figure 13. The current across the temporary junction between cables operated at 28 V and 50 V (top) indicates temporary contact between the conductors of both circuits. The electrical resistance (bottom) between the circuits was calculated from the measured potential difference between the circuits and the measured current (EMI Exp. 4633)

From the electrical measurements made during impact (Fig. 13), the potential difference between the cables operating at 28 V and those operating at 50 V was determined. This voltage should be constant if there is no conducting bridge between the circuits. Simultaneously, an electrical current flowing from one circuit into the other was measured, peaking at about 9 A. This indicates that the conductors from both circuits were in temporary contact during impact (ca.

60  $\mu\text{s}$ ). From this information, the electrical resistance between the cables operated at 28 V and those operated at 50 V was calculated. As can be seen from the first plot in Fig. 13, the resistance approaches zero at approximately 53  $\mu\text{s}$  and 80  $\mu\text{s}$  after impact of the projectile on the CFRP front face-sheet. For reasons of amplifier noise and oscilloscope digitization in this plot 100  $\Omega$  resistance corresponds to “infinite resistance” i.e., no contact.

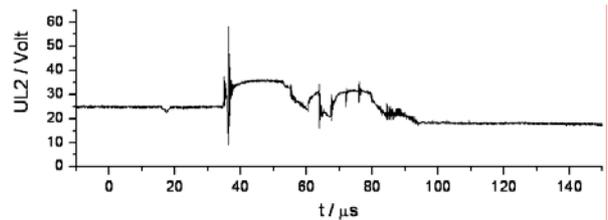
Figure 14. Voltage recorded in 28 V circuit during impact (EMI Exp. 4633)

In Fig. 14, the voltage measured at the load resistor of the 28 V circuit are shown. The signals recorded during the first 100  $\mu\text{s}$  after impact reveal very high temporary voltage peaks (and associated current peaks). In the 28 V circuit, the voltage varies between 9 V and 58 V during impact of the main portion of the fragment cloud on the harness. In the 50 V circuit (not shown here), the voltage varies between 3 V and 67 V during the same time period. The duration of this large perturbation lasts for approximately 2  $\mu\text{s}$ . The subsequent smaller perturbations (in the order of  $\pm 15\text{ V}$ ) last several tens of  $\mu\text{s}$ .
