Effects of Gamma Ray Irradiation on Ejecta Size from CFRP Plates

ABSTRACT

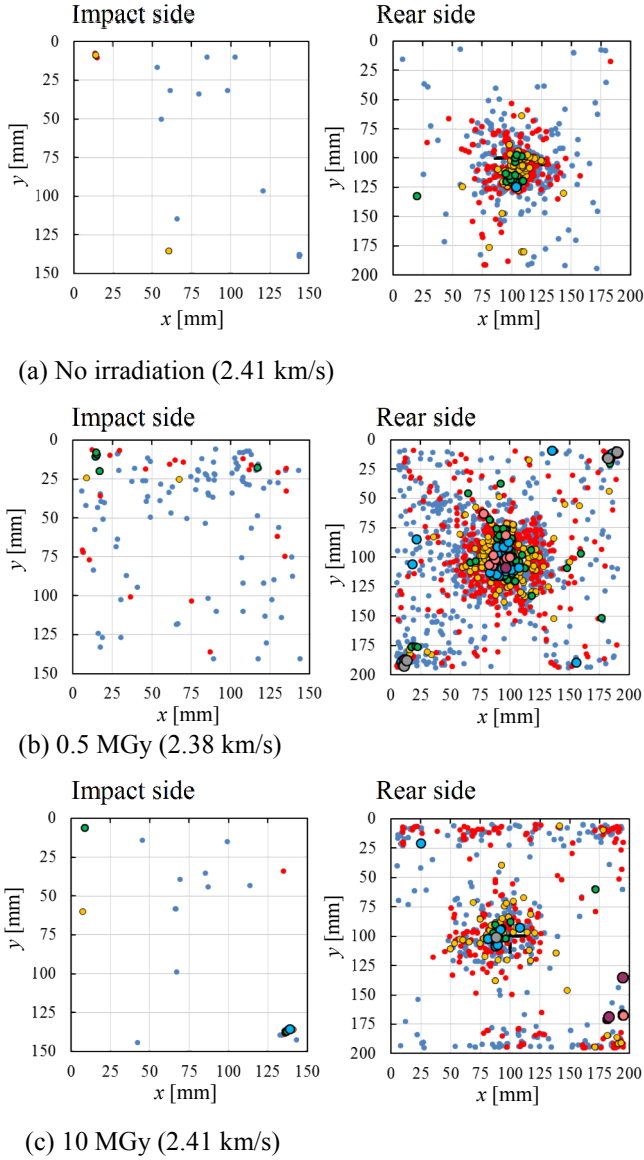
Figure 8. Photographs of witness plates after impact experiments

Fig. 8 shows analysed results. Fig. 9 shows the meaning of symbols in Fig. 8. On the impact side, a few craters impacted by fragments were observed. There was no clear tendency in three results on impact side. On the rear side, three results show that the crater areas slightly spread from top left to bottom right along to the fiber direction of the outermost layer on the rear side. The

spread area from 0.5 MGy specimen was wider than that from the unirradiated specimen. The spread area from 0.5 MGy specimen was wider than the unirradiated specimens and 10 MGy specimen, but the crater number from 0.5 MGy specimen seemed to be higher than that from 10 MGy specimen.

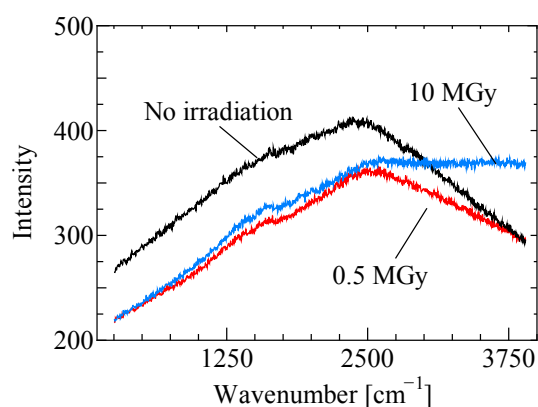
Figure 10. Results of laser Raman spectroscopy

Finally, laser Raman spectroscopy (JASCO, NRS-3300) was applied to the CFRP specimens. A Raman spectrum is shown in Fig. 10. Significant Raman scattering signals were not detected because fluorescence background problems seemed to occur. However, because the trend of fluorescence background was changed by the irradiation (total dose), it is highly possible that some chemical reaction of CFRP such as molecular chain breakage and crosslinking were occurred by the irradiation. Further chemical analyses are needed in order to clarify chemical reaction.
